Service Repair Documentation Level 3 (Basic) – ME75

Release	Date	Department	Notes to change
R 1.0	13.10.2005	BenQ Mobile CC S CES	New document

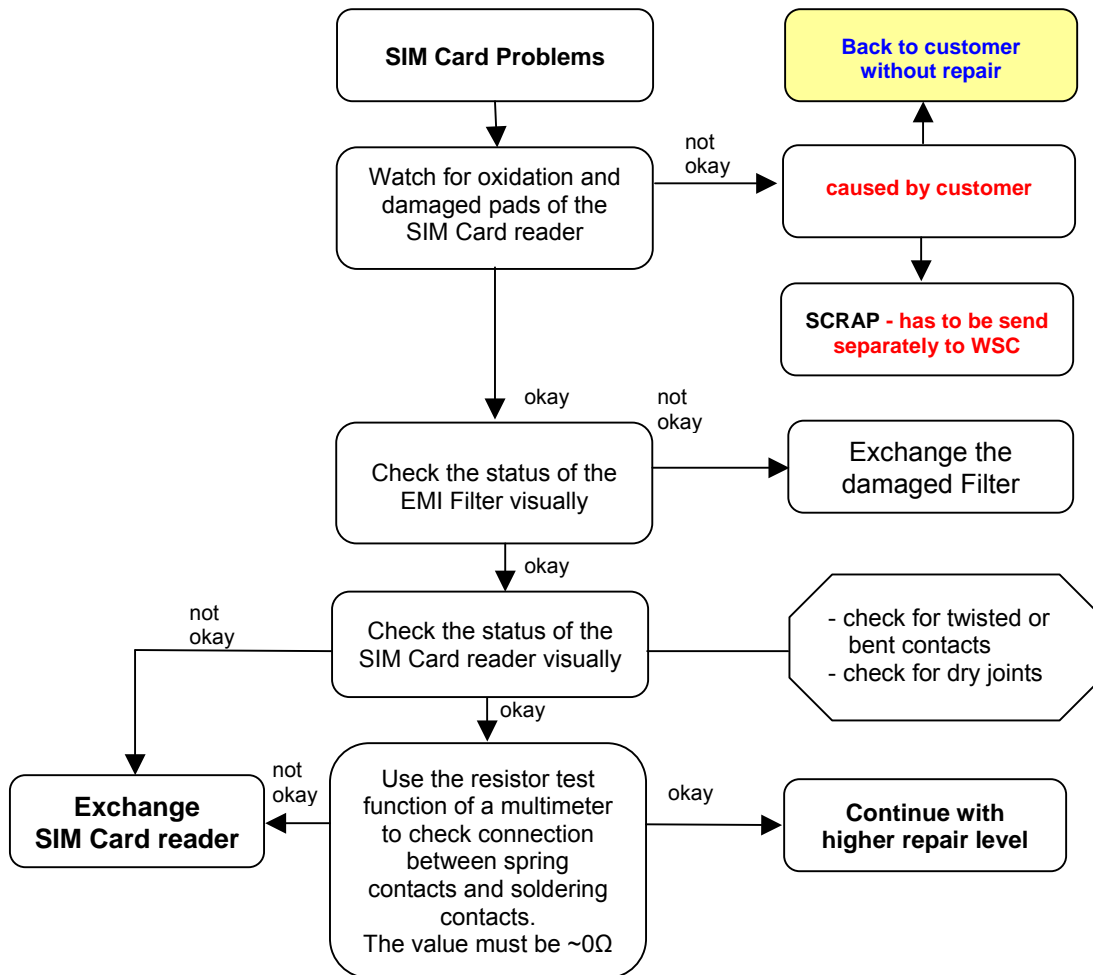
Connector SIM Card Reader

Fault Symptoms	
Customer: Handset does not accept SIM card	GRT: SIM Card Problems

Use soldering iron to remove defective component. Avoid excessive heat! Watch surrounding components! Resolder new component afterwards.

E-commerce order number: L50634-Z97-C406

Soldering temperature: ~ 360°C TIP Temp.

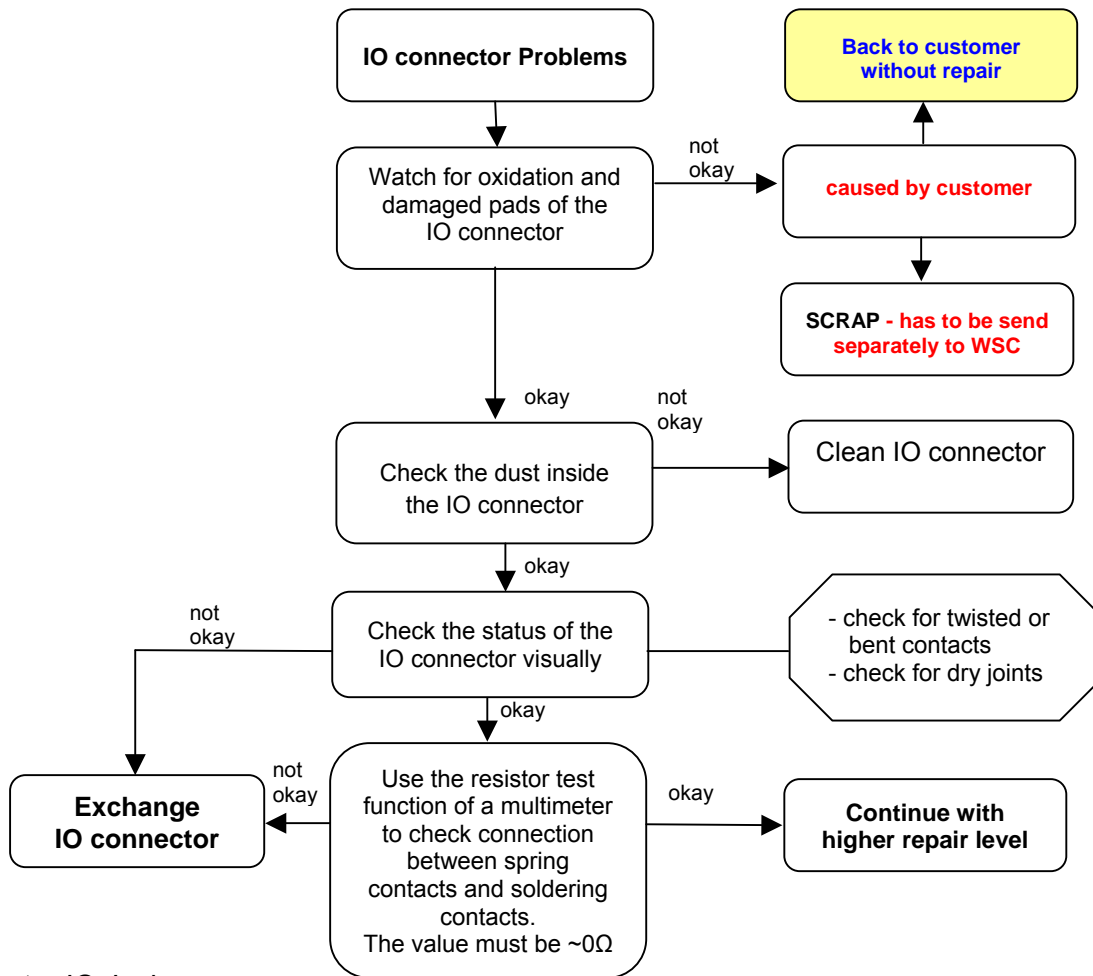
Connector IO Jack

Fault Symptoms	
Customer: Charging Problems Problems with external loudspeaker or microphone when using a car kit Problems with accessories connected at the IO connector	GRT: No connection to GRT

Use soldering iron to remove defective component. Avoid excessive heat! Watch surrounding components! Resolder new component afterwards.

E-commerce order number: L36334-Z93-C303
 E-commerce order name: IO-JACK SLIM 12-POL
 Soldering temperature: ~ 360°C TIP Temp.

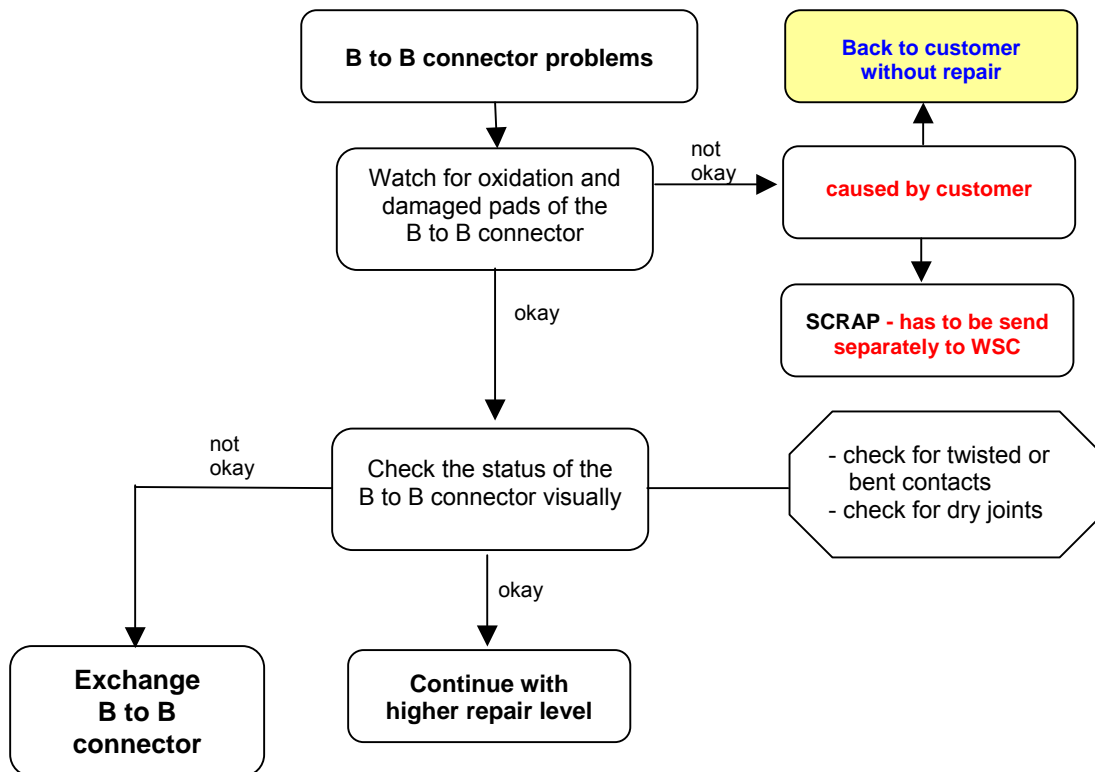
Connector Board to Board

Fault Symptoms	
Customer: Upper slider keyboard malfunction Upper slider keypad illumination does not work Display problems	GRT: Keyboard malfunction Current measured failed

Use hot air blower to remove defective component. Avoid excessive heat! Watch surrounding components! Resolder new component afterwards.

E-commerce order number: L50634-Z97-C340
 E-commerce order name: BOARD TO BOARD 30-POL
 Soldering temperature: ~ 360°C TIP Temp.

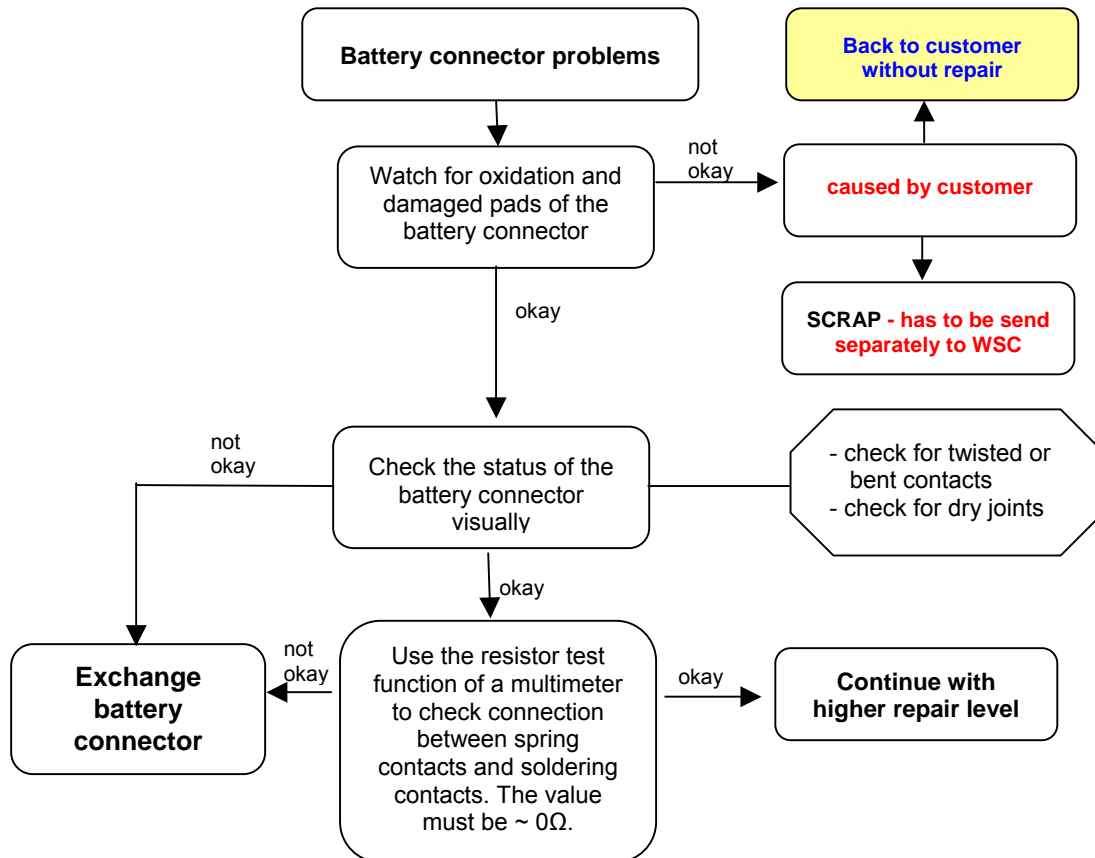
Connector BATTERY

Fault Symptoms	
Customer: Mobile does not switch on	GRT: No connection to GRT

Use hot air blower to remove defective component. Avoid excessive heat! Watch surrounding components! Resolder new component afterwards.

E-commerce order number: L36334-Z97-C213
 E-commerce order name: CONNECTOR BATTERY 3-POL
 Soldering temperature: ~ 360°C TIP Temp.
 IRIS Diagnose Code: 13000 Battery/Mechanical Damage

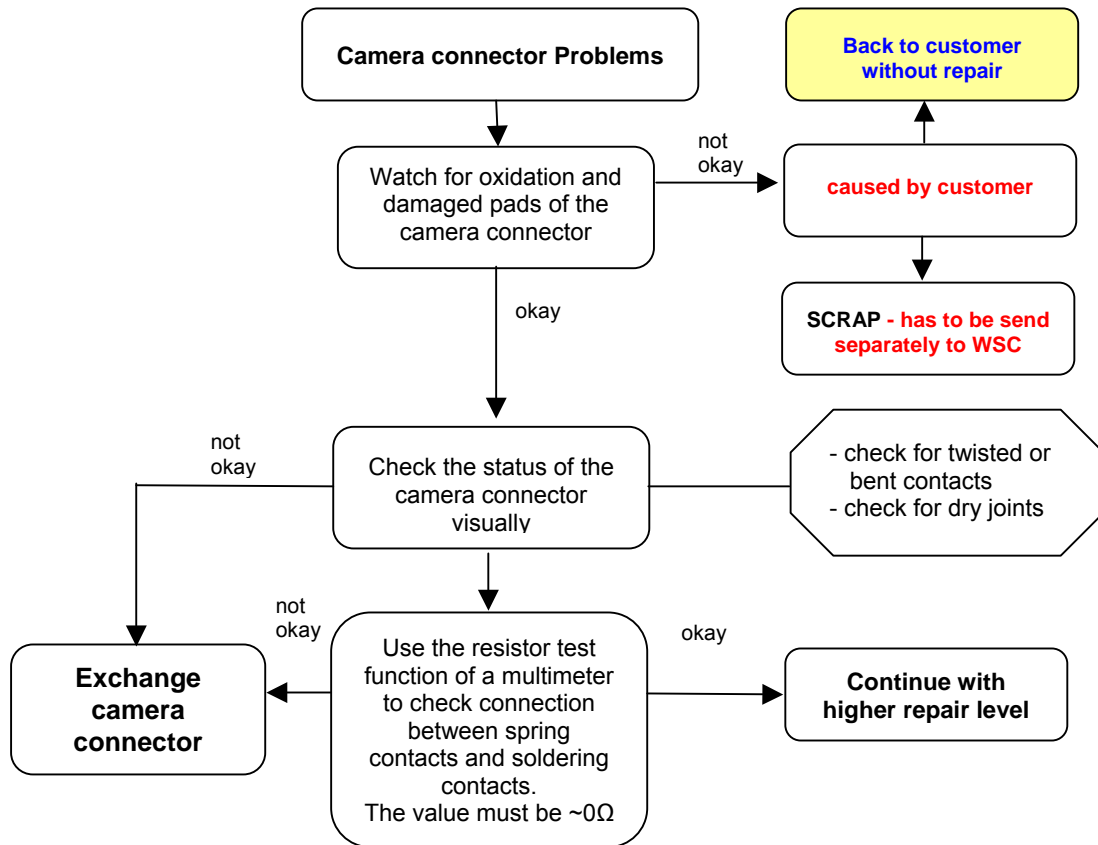
Connector CAMERA

Fault Symptoms	
Customer: Camera malfunction	GRT: Tbd.

Use hot air blower to remove defective component. Avoid excessive heat! Watch surrounding components! Resolder new component afterwards.

E-commerce order number: L50634-Z97-C379
 E-commerce order name: CONNECTOR CAMERA-SOCKET
 Soldering temperature: ~ 360°C TIP Temp.
 IRIS Diagnose Code: BA000 Accessories / Camera

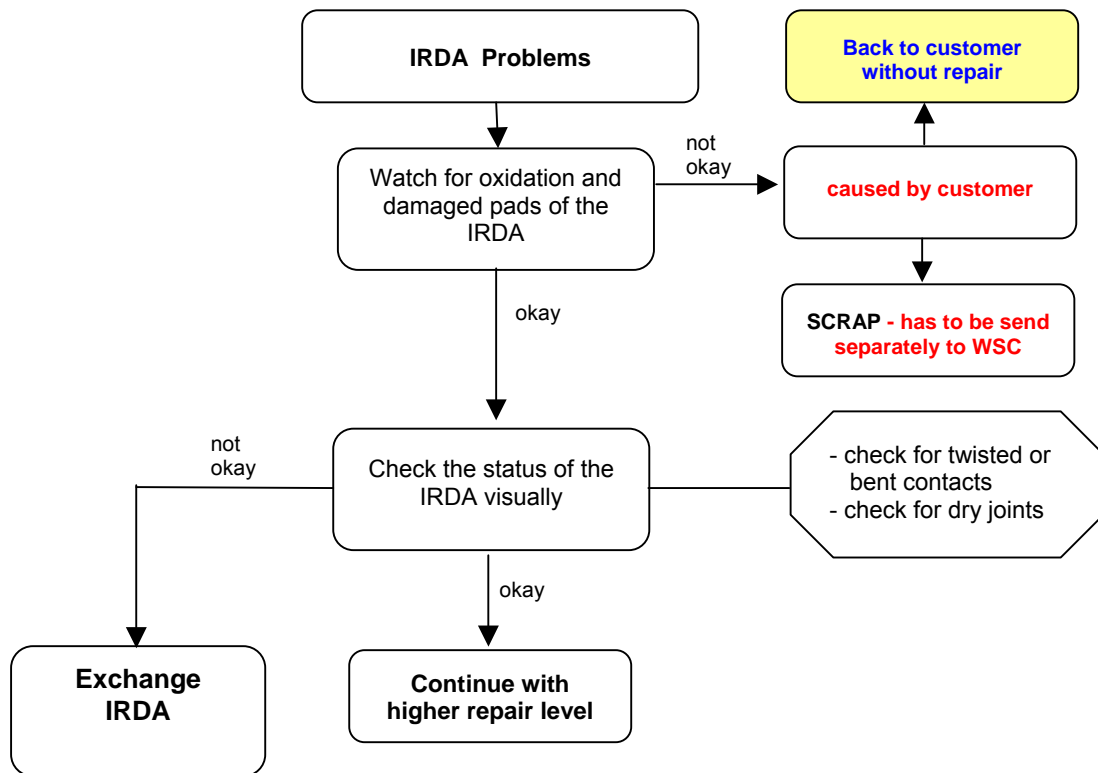
IRDA

Fault Symptoms	
Customer: No infrared connection possible	GRT: Tbd.

Use hot air blower to remove defective component. Avoid excessive heat! Watch surrounding components! Resolder new component afterwards.

E-commerce order number: L36197-F5008-F492

Soldering temperature: ~ 360°C TIP Temp.
