Trouble Shooting Guide, SP/Mechanical

Applicable for Z200/Z208

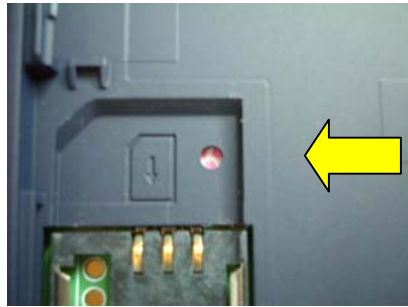
Fig1.1

In the phone there is placed a Water Damage Indicator that can give you a hint to see if the phone is damage by liquid or not. This Water Damage Indicator is located near the SIM reader (Fig.1.1) and it is possible to see it without disassemble the phone.

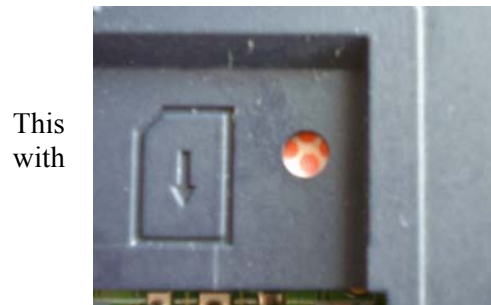
Fig1.2

Water Damage Indicator has not been in contact liquid.

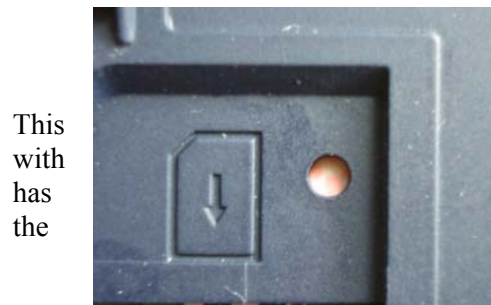
Fig1.3

Water Damage Indicator has been in contact liquid. The colour has been changed, the red dots turn into pink dots. In this case you should check phone for liquid damage.

Make a general visual inspection for corrosion or oxidation from possible liquid damage. No further action should be taken for a liquid damaged phone. Handle the unit according to local company or GSP directives.

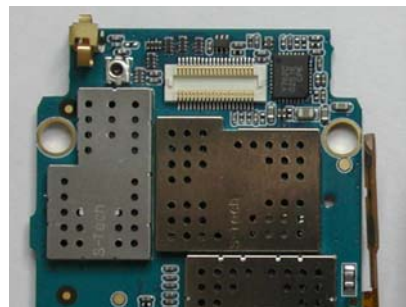
Fig.3.6

- Check that the Flex film (BTB to FPC) is connection well. Re-assembly it if necessary.
- Check that the BTB connector (Fig3.6) and Flex film (BTB to FPC) (Fig.3.7) are not incorrectly soldered, mechanical damaged, dirty or oxidized. Clean or Replace it if necessary.

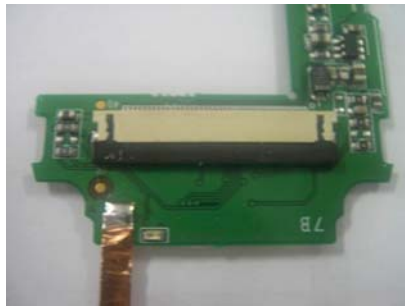
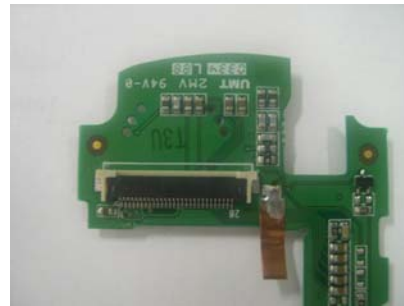
- If all segments are missing check that the LCD connector (Fig.5.1 & Fig.5.2) and Flex film (BTB to FPC) (Fig 5.3) are not mechanical damaged, dirty or oxidized. Replace the Upper PCB Assy (Fig 5.4) or Flex film (BTB to FPC) if necessary.

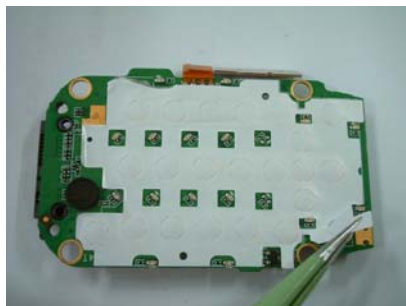
Fig.8.1

- Check that the mechanical response feels normal, and that all the keys had been shown in the display. If necessary replace the dome foil (Fig.8.1).
- Turn the phone on. Go to service test menu; choose “3.Keyboard”. Check the Sidekey (no click should be heard). Check that the mechanical response feels normal.

- If the Dome Foil will be replaced, make sure that the surface on the PCB is cleaned, remove glue and dust from the PCB Surface.
- If only the On bottom active, please measure the voltage of keyboard bottom (Fig8.3), it should be 3.0V, if the voltage is only 1.5V, re-solder or replace the Sidekey PCB (Fig8.2).

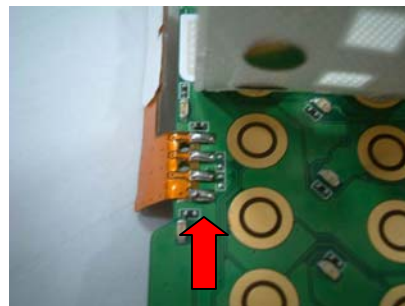
Fig.8.2

- Check that the Sidekey not mechanical damaged.
- Check that the Sidekey PCB (Fig.8.2.) is incorrectly soldered, not mechanical damaged, dirty or oxidized.

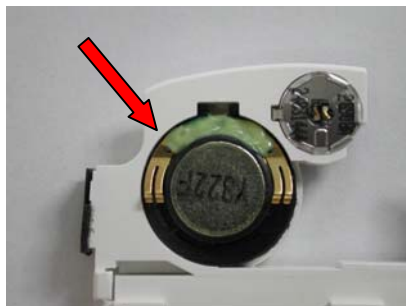
Fig.9.1

- Check that the Loudspeaker (Polyphonic) Assy (Fig.9.1) is not mechanical damaged, dirty or oxidized. Replace it necessary.
- Check that Loudspeaker (Polyphonic) Assy pads (Fig.9.2) are not dirty or oxidized. Clean them if necessary.

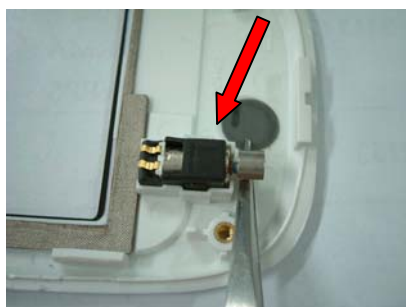
Fig.9.3

- Turn on the phone. Go to service test menu; choose “7.Vibrator” press any key to check if the vibrator is working properly.
- Check that the Vibrator Assy (Fig.9.3) is not mechanical damaged, dirty or oxidized. Replace it if necessary.

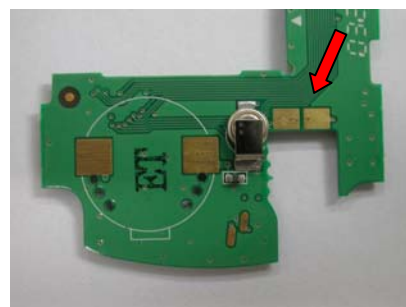
Fig.9.4

- Check that the vibrator pads on the PCB (Fig.9.4) are not dirty or oxidized. Clean them if necessary.

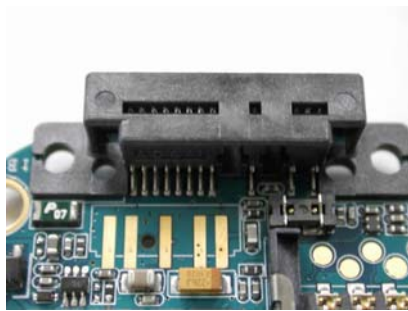
Fig.10.1

- Make a general visual inspection for corrosion or oxidation from liquid damage according to point 1.2.
- Check that the system connector (Fig.10.1.) is incorrectly soldered, not mechanical damaged, dirty or oxidized. Clean it if necessary.

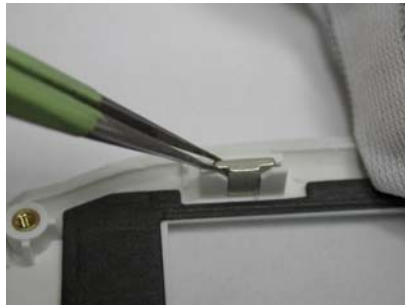
Fig.12.1

- Make a general visual inspection for corrosion or oxidation from liquid damage according to point 1.2.
- Turn on the phone. Go to service test menu; choose “9.Flip Counter”. Open the shell; the flip counter value will be increased in the display.
- If the back ground light is turned on when the shell is closed, or if the Main display takes long time to load up when the shell is opened, reverse the magnet according to the Working Instruction.
- Check that the magnet (Fig.12.1.) is not mechanical damaged, dirty or oxidized. Replace the Upper inside Cover Assy if necessary.
