Service Repair Documentation

Level 2.5 – CFX 65

1	
Service Repair Documentation Level 2.5 - CFX65	V1.1

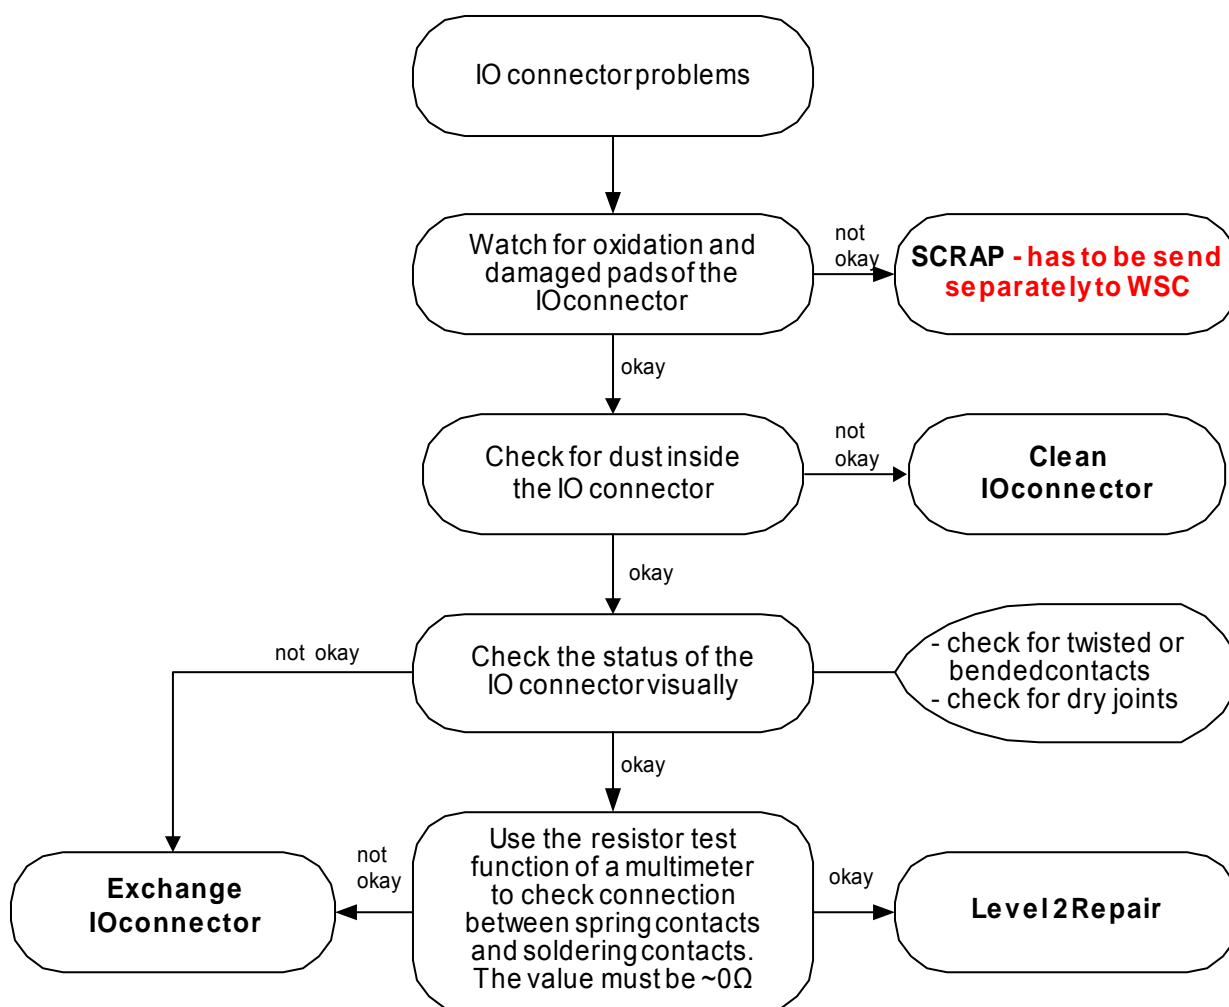
7. I/O connector (J304)

Fault Symptoms	
Customer	GRT
Charging problems	No GRT support
Problems with external loudspeaker or microphone when using a car kit	No GRT support
Problems with accessories connected at the I/O connector	No GRT support

Use soldering iron to remove defective component. Avoid excessive heat! Watch surrounding components! Resolder new component afterwards.

Soldering temperature: 240 - 255°C

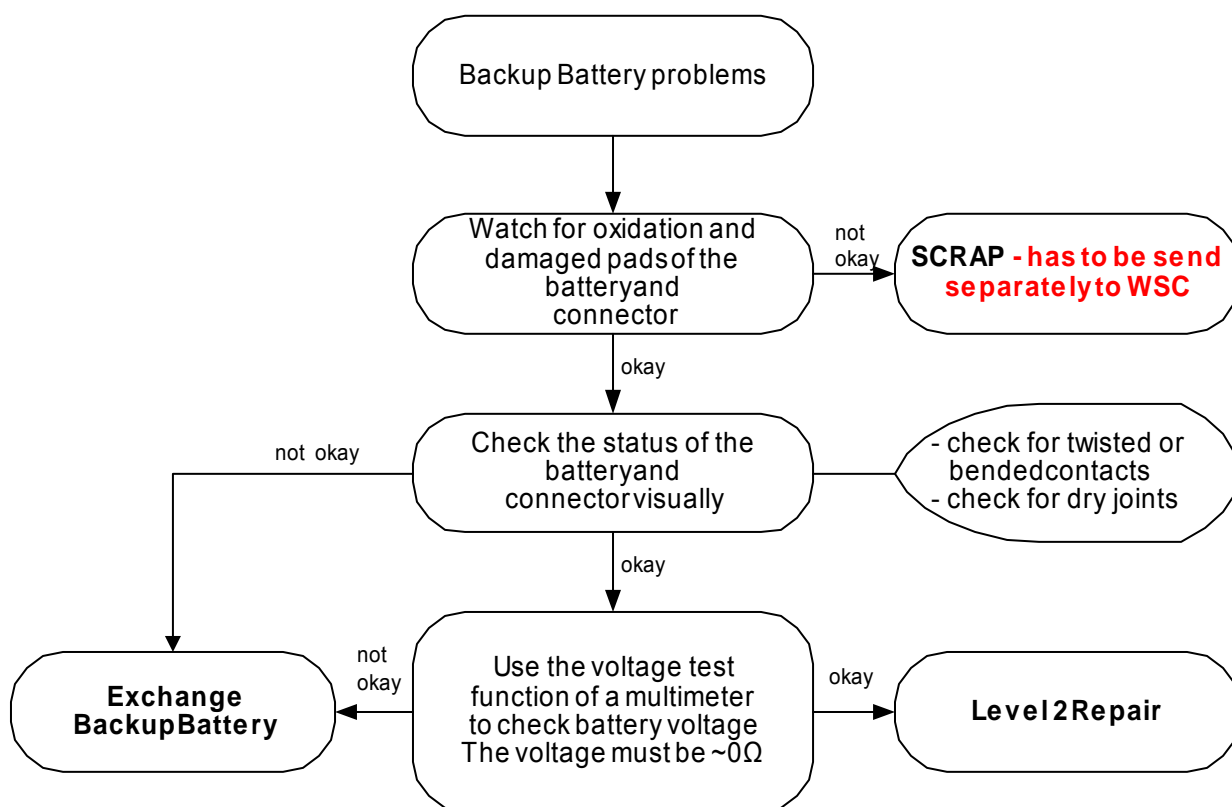
8. Backup battery (BT414R)

Fault Symptoms	
Customer	GRT
After removing and reassembling the battery, the time is not correct or default value.	No GRT support

Backup battery

Use soldering iron to remove defective component. Avoid excessive heat! Watch surrounding components! Resolder new component afterwards.

Soldering temperature: 220 - 230°C

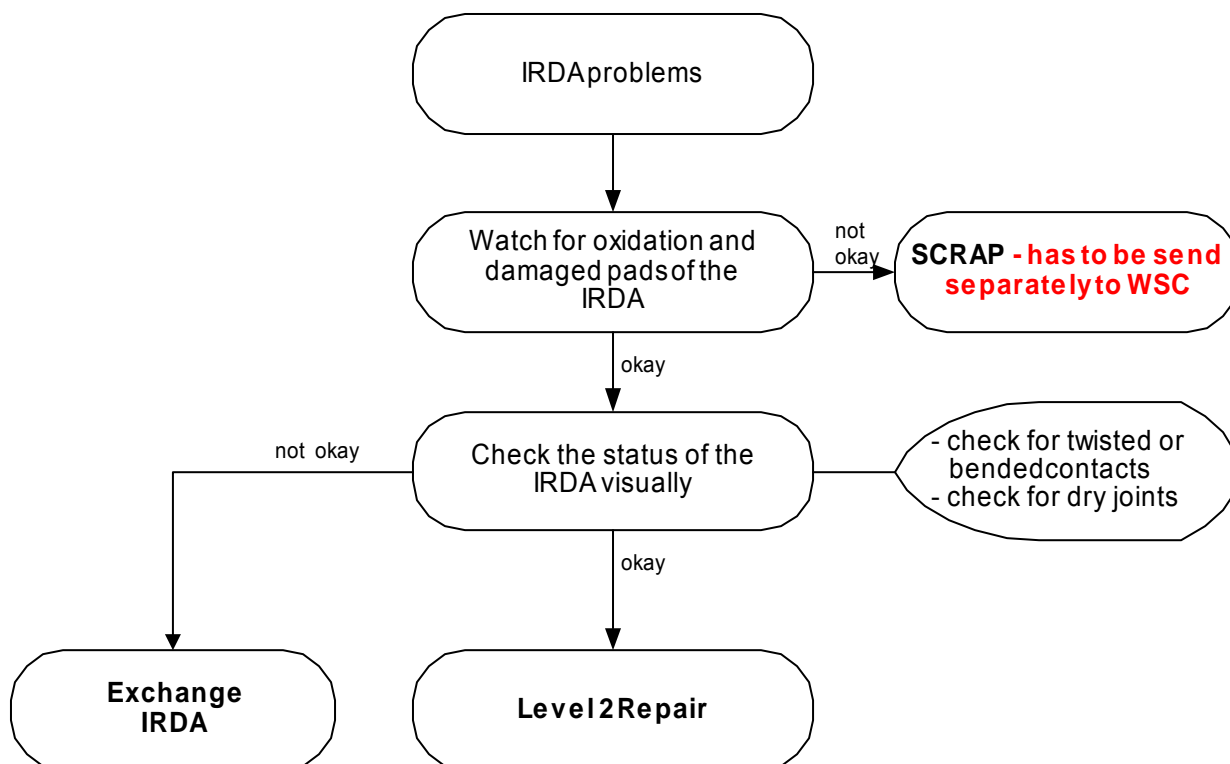
9. IRDA (U103)

Fault Symptoms	
Customer	GRT
No infrared connection possible	No GRT support

IRDA

Use hot air blower to remove defective component. Avoid excessive heat! Watch surrounding components! Resolder new component afterwards.

Soldering temperature: 240 - 255°C

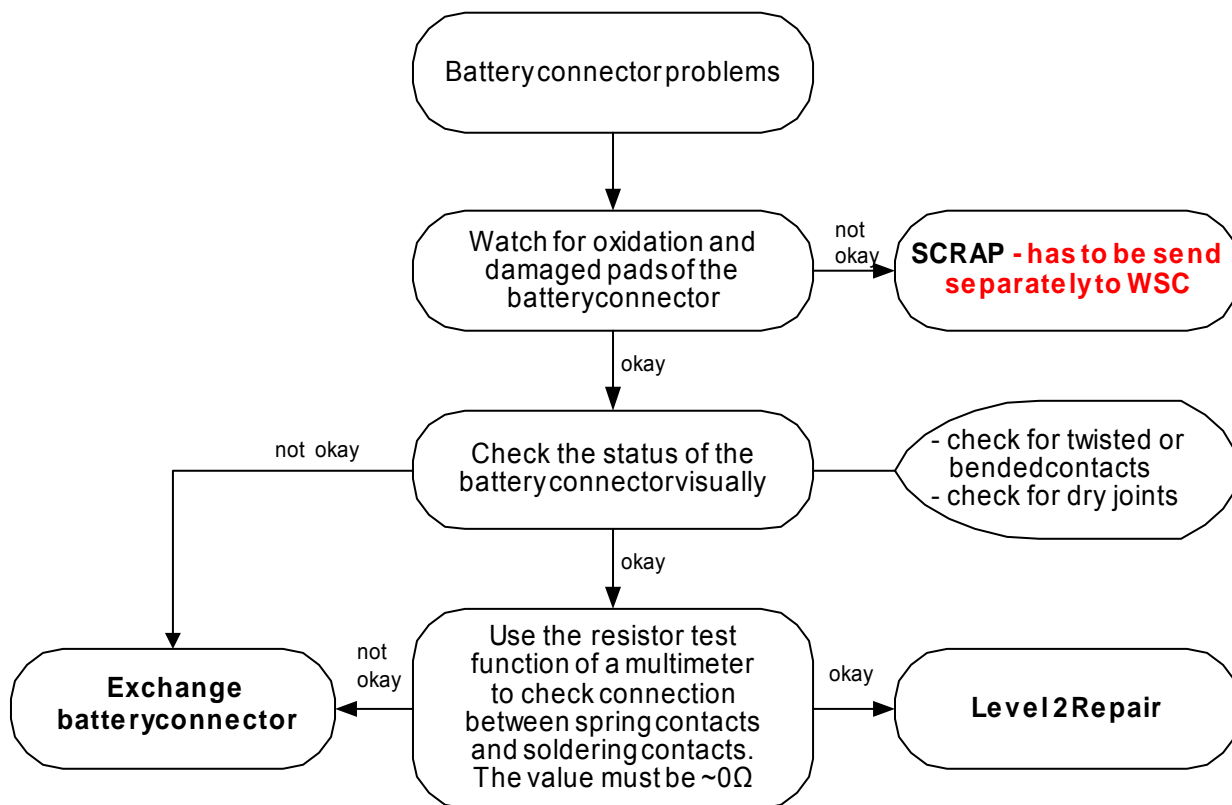
10. Battery connector (J300)

Fault Symptoms	
Customer	GRT
Mobile does not switch on	No GRT support

Battery connector

Use hot air blower to remove defective component. Avoid excessive heat! Watch surrounding components! Resolder new component afterwards.

Soldering temperature: 240 - 255°C

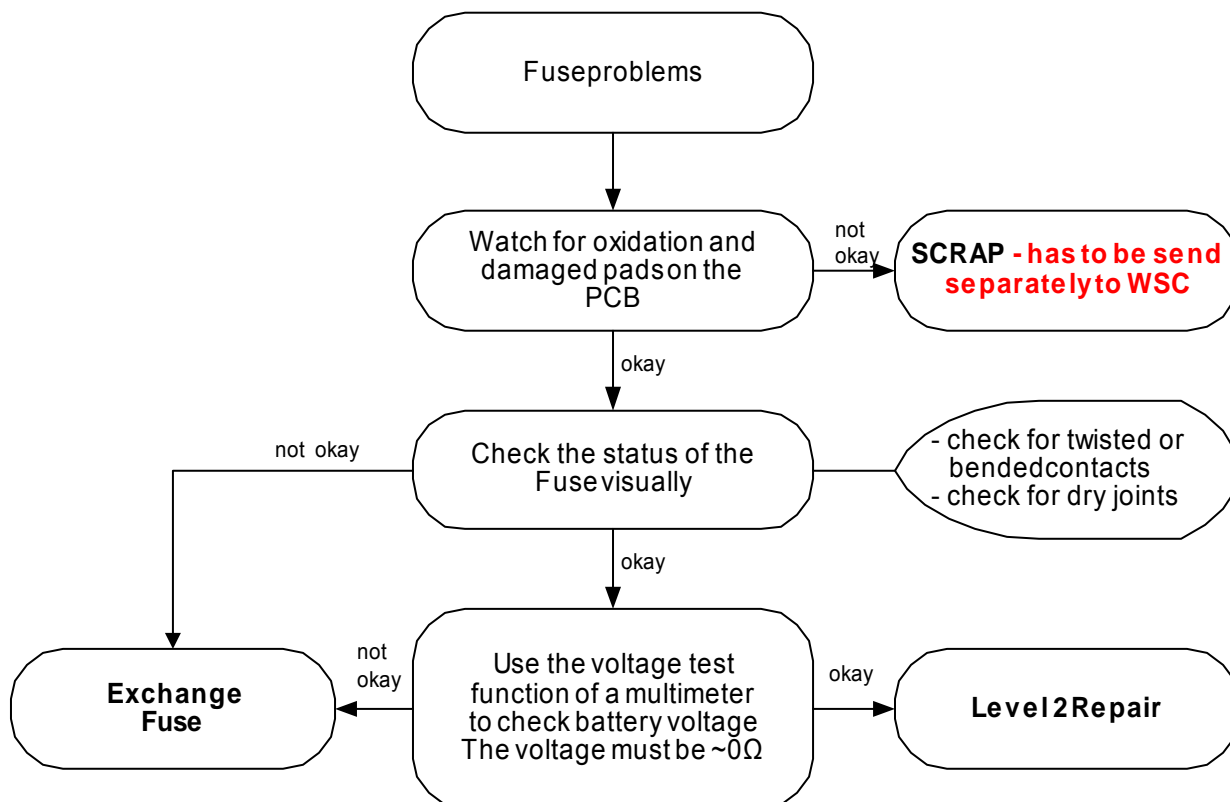
11. Fuse (F300)

Fault Symptoms	
Customer	GRT
Battery charging does not work	No GRT support

Fuse

Use soldering iron to remove defective component. Avoid excessive heat! Watch surrounding components! Resolder new component afterwards.

Soldering temperature: 240 - 255°C

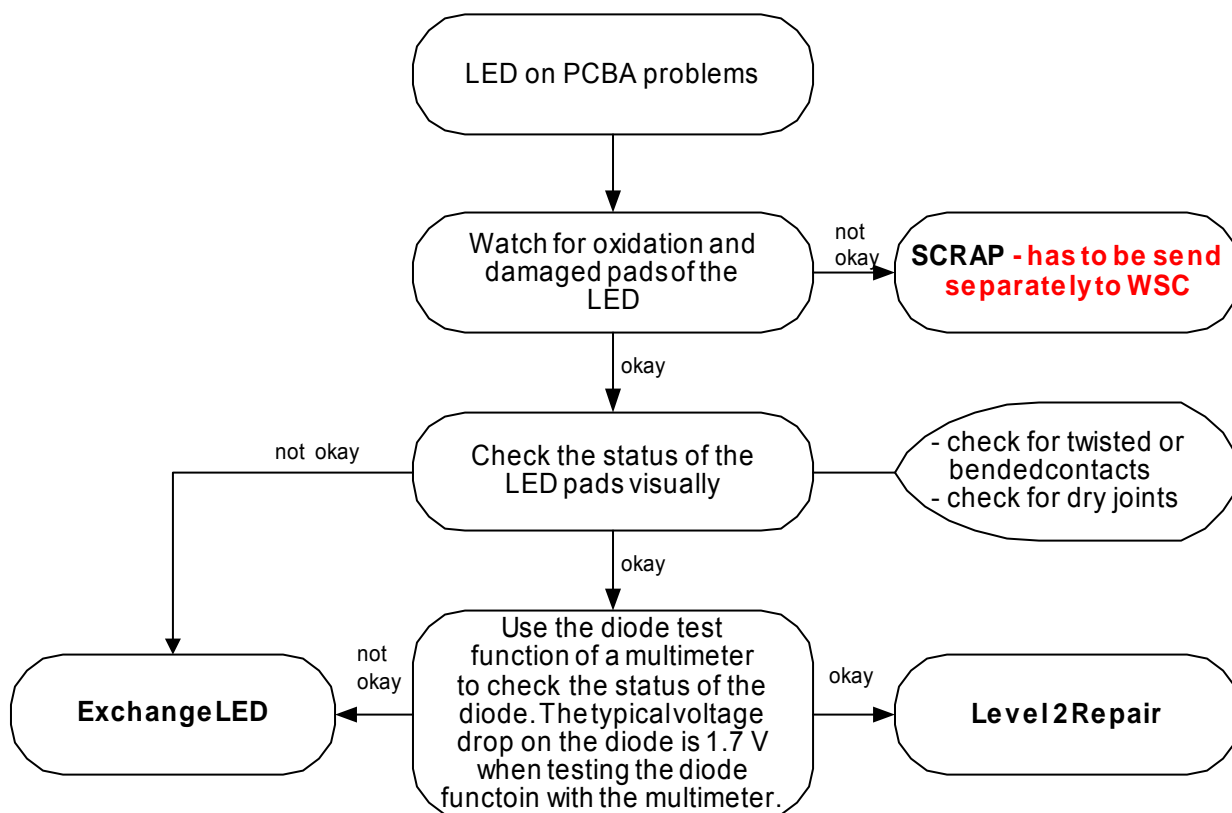
12. LED on PCBA

Fault Symptoms	
Customer	GRT
LED does not work or not bright	No GRT support

LED

Use soldering iron to remove defective component. Avoid excessive heat! Watch surrounding components! Resolder new component afterwards.

Soldering temperature: 240 - 255°C
