S10 / S10 MMI

Repair Documentation

Level 2.5

V 4.4

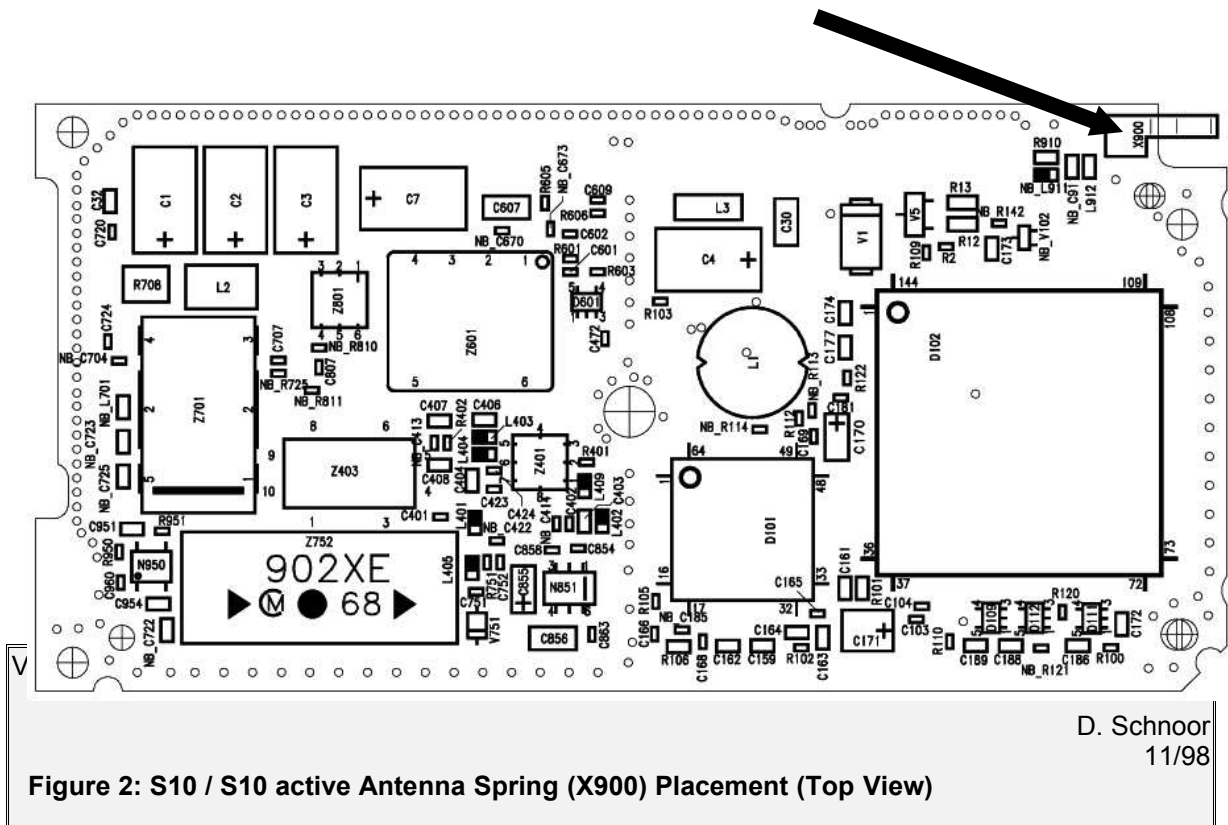
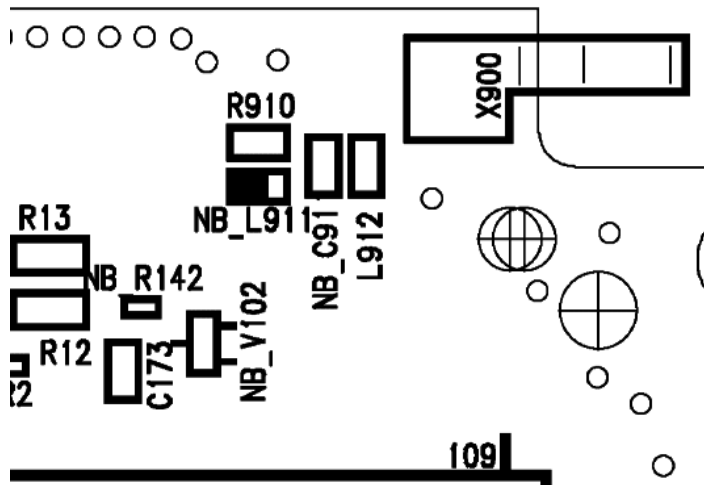
Figure 1: S10 / S10 active Board Antenna Spring Side

Customers experience a low Rx sensitivity of the handset, have problems registering to the network and making calls.

The GSM-Tester will show a low Tx-Power only on the *internal* antenna (aerial coupler measurement!).

Visually check the status of the antenna spring. Look for a bent contact or dry soldering joint.

Use soldering iron to remove defective spring.

Resolder new spring afterwards.

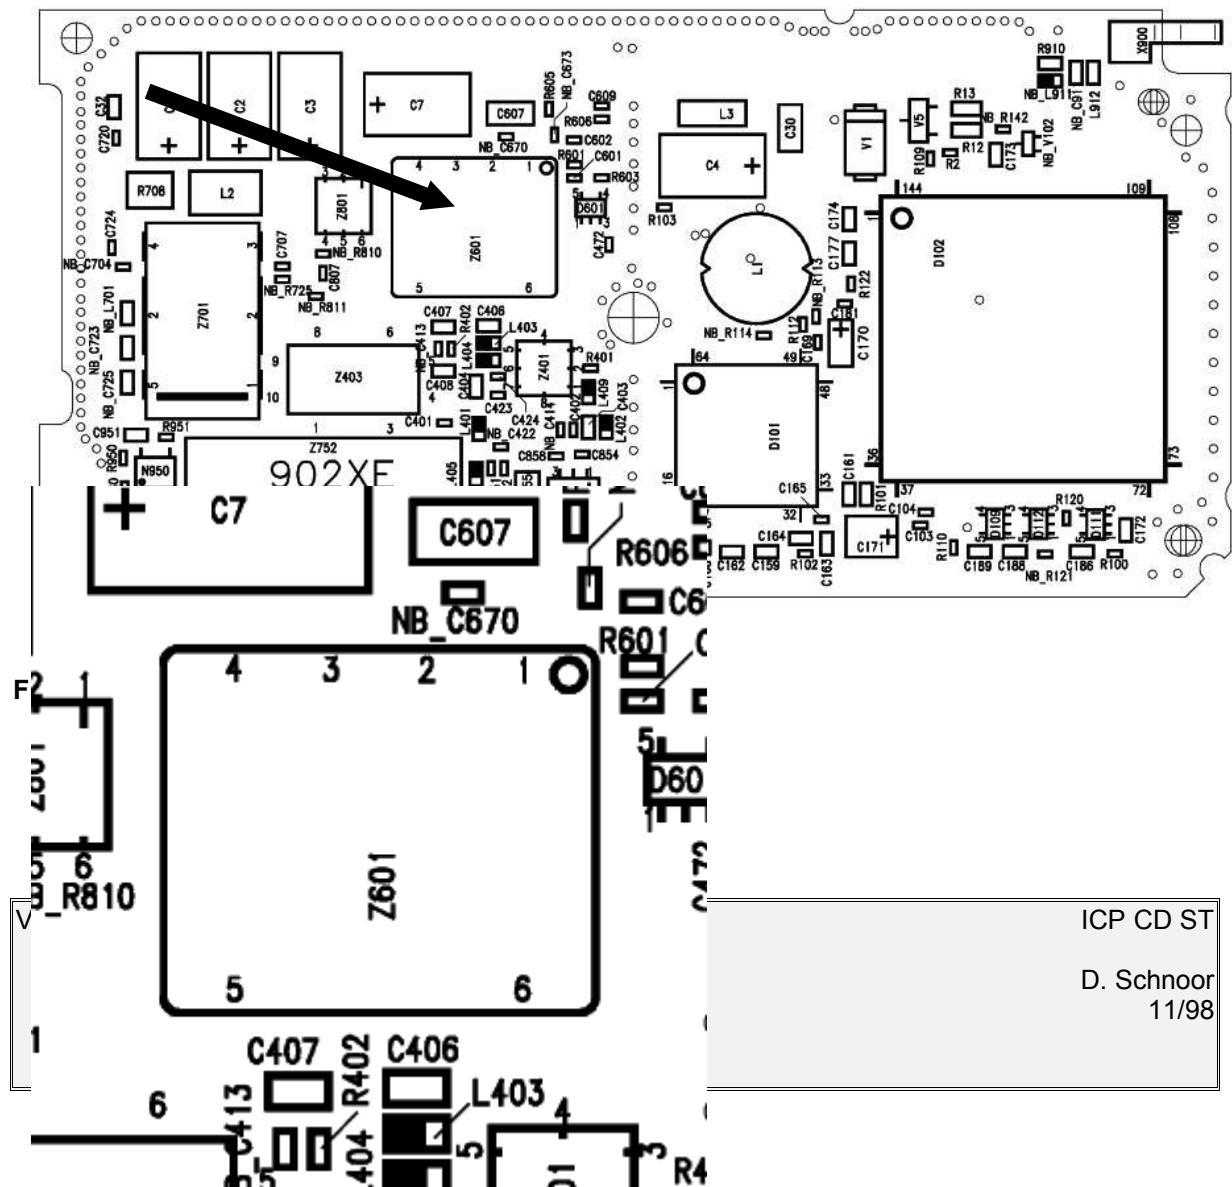
Figure 1: S10 Board TCXO Side

Frequency error in synchronized mode >90 Hz
No location update possible

If the frequency error is higher than 2kHz, the TCXO has to be replaced.

Use hot air blower to remove defective TCXO.
Avoid excessive heat!
Watch surrounding components!

Resolder new TCXO afterwards.

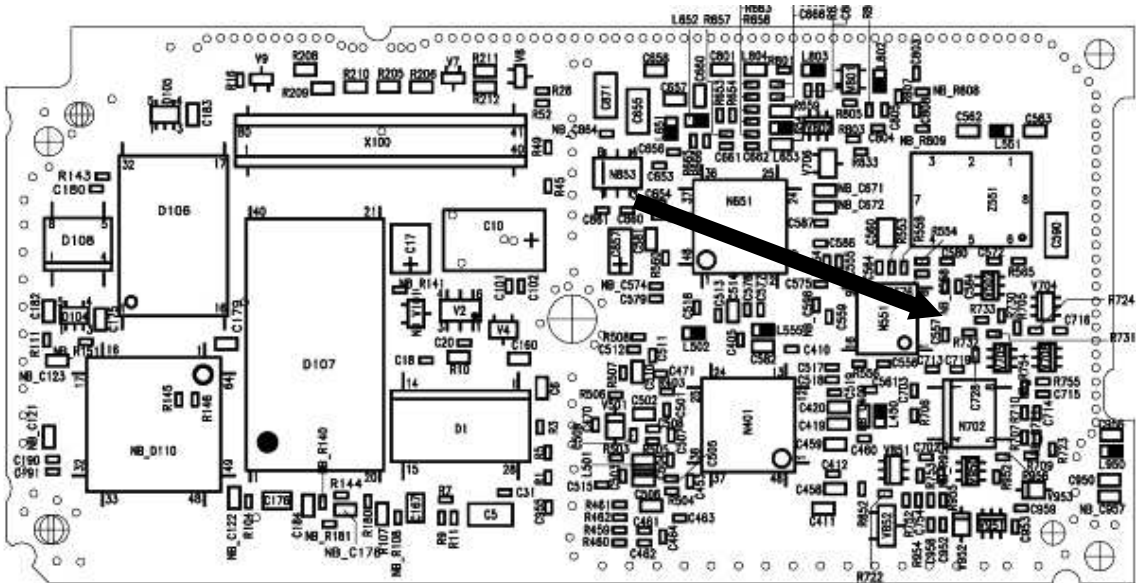
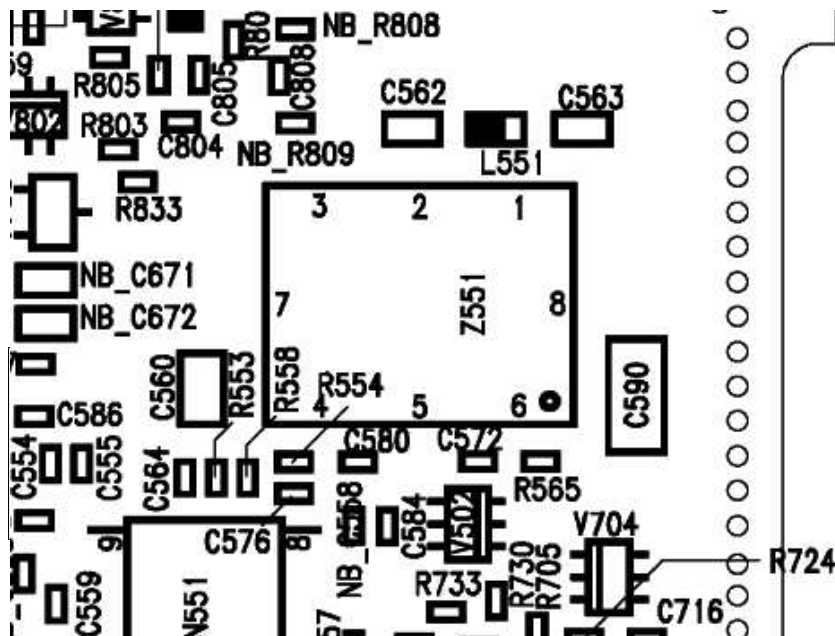
Figure 1: S10 Board VCO Side

The VCO (Voltage Controlled Oscillator) is responsible for generating RF frequencies of the handset.

If it is defective, the handset cannot synchronize to the base station any more.

Use hot air blower to remove defective VCO.
Avoid excessive heat!
Watch surrounding components!

Resolder new VCO afterwards.

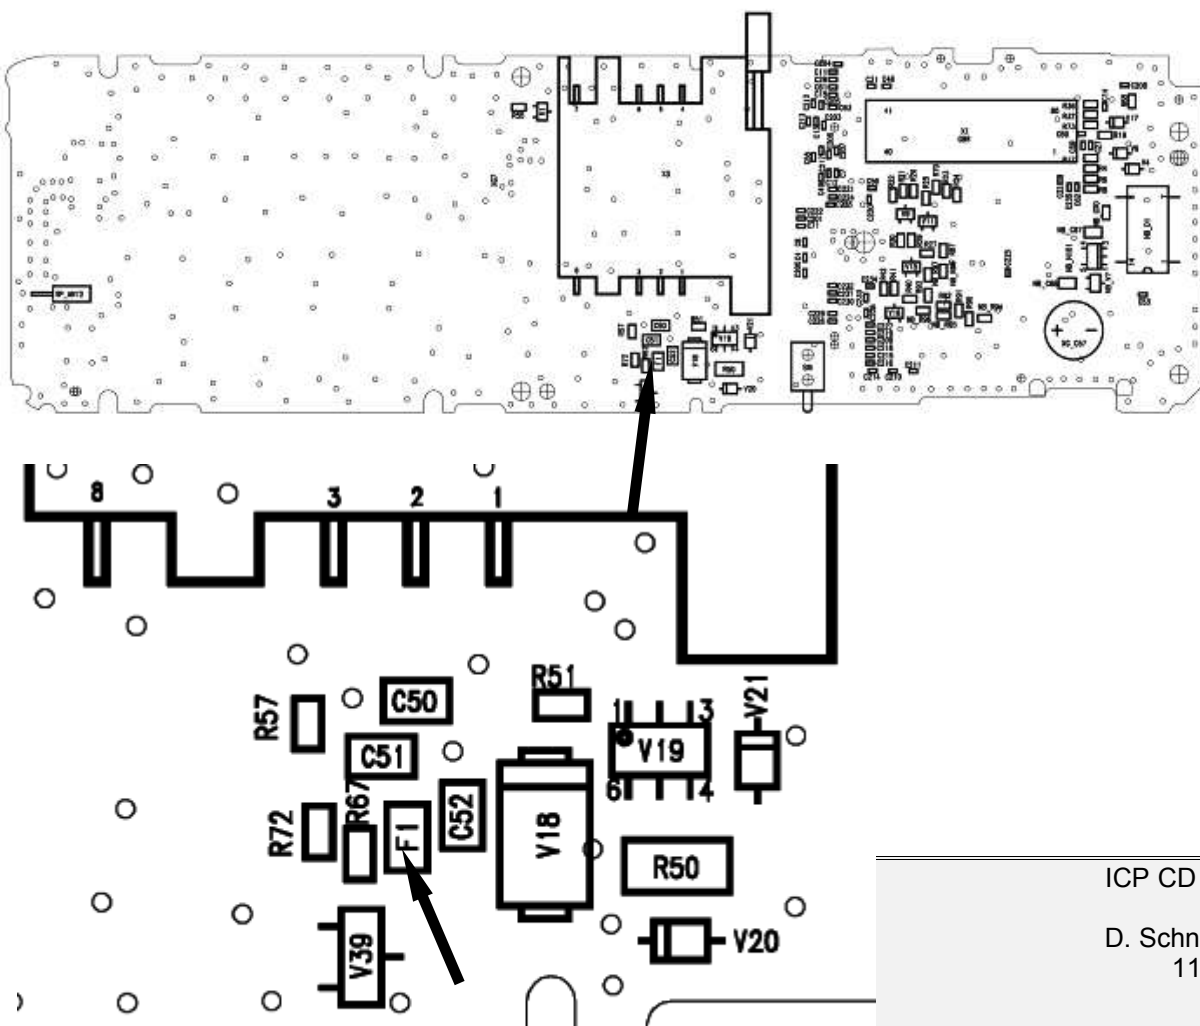
Figure 1: S10 / S10 active MMI Board 1A Fuse Side

Battery charging not possible

Check the status of the fuse by measuring its resistance with a multimeter. The fuse is defective if the resistance higher than 10 ohms

Use soldering iron to remove defective fuse.
Avoid excessive heat!
Watch surrounding components!

Resolder new fuse afterwards.

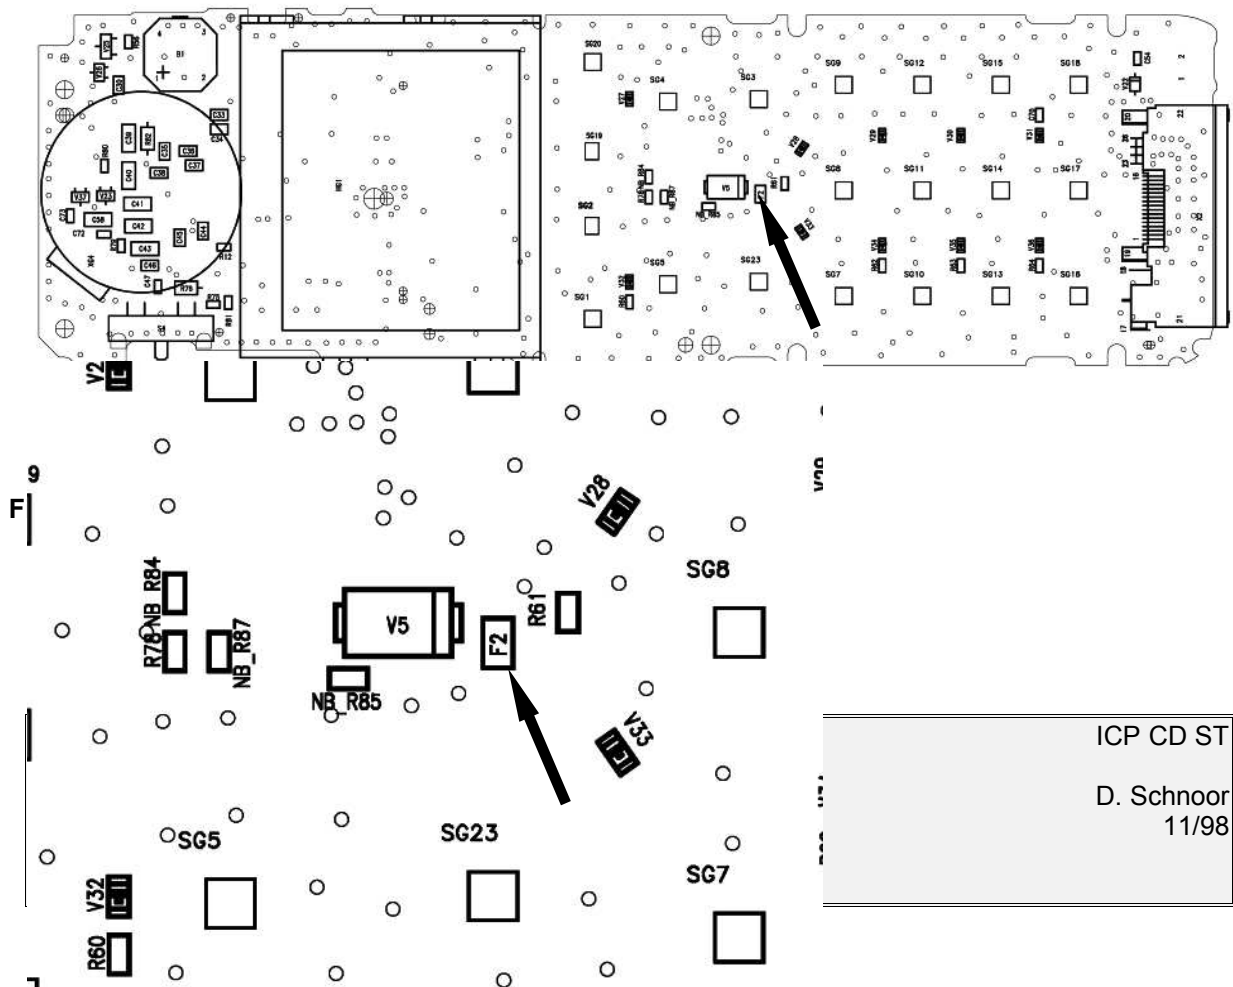
Figure 1: S10 / S10 active MMI Board 0.25A Fuse Side

Supplying of external accessories through the handset's
bottom connector is not possible

Check the status of the fuse by measuring its resistance with a multimeter. The fuse is defective if the resistance higher than 10 ohms

Use soldering iron to remove defective fuse.
Avoid excessive heat!
Watch surrounding components!

Resolder new fuse afterwards.

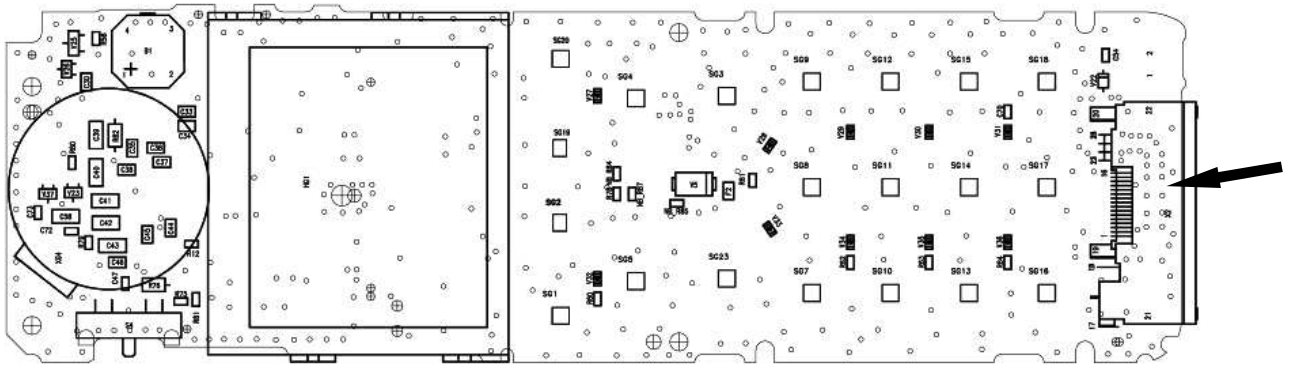
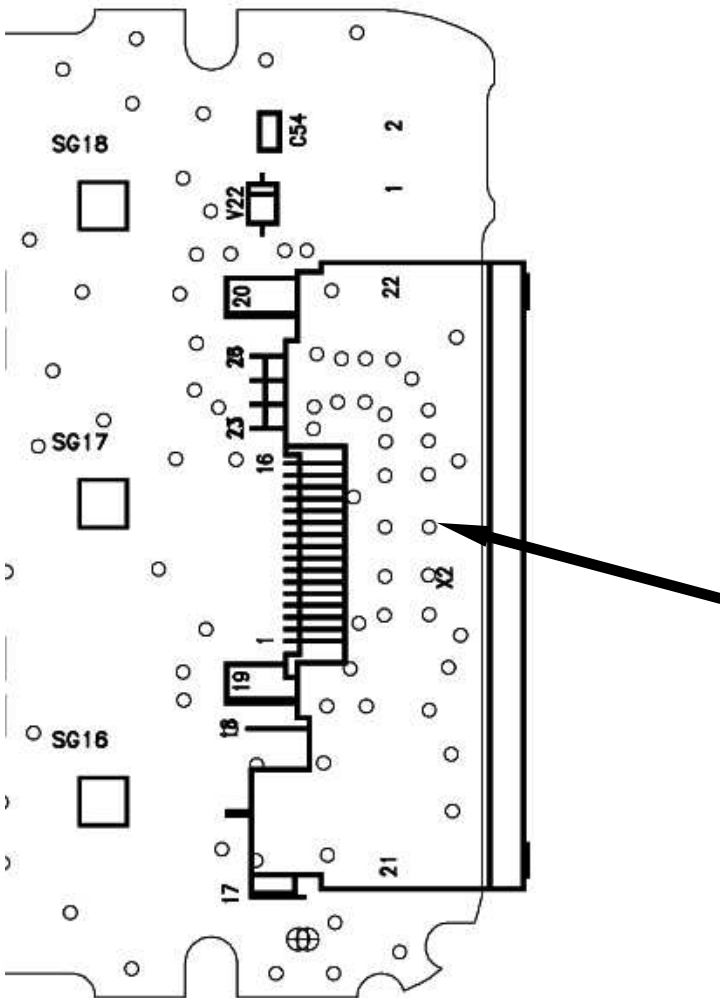
Figure 1: S10 / S10 active MMI Board Bottom Connector Side

Charging or operation in a car kit not possible.

Output power problems on the external antenna only.

Visually check the bottom connector. Watch for dry joints.

Use hot air blower to remove defective connector.
Avoid excessive heat!
Watch surrounding components!

Resolder new connector afterwards.
Make sure that you use just very little flux, otherwise the connector contacts can become dirty.

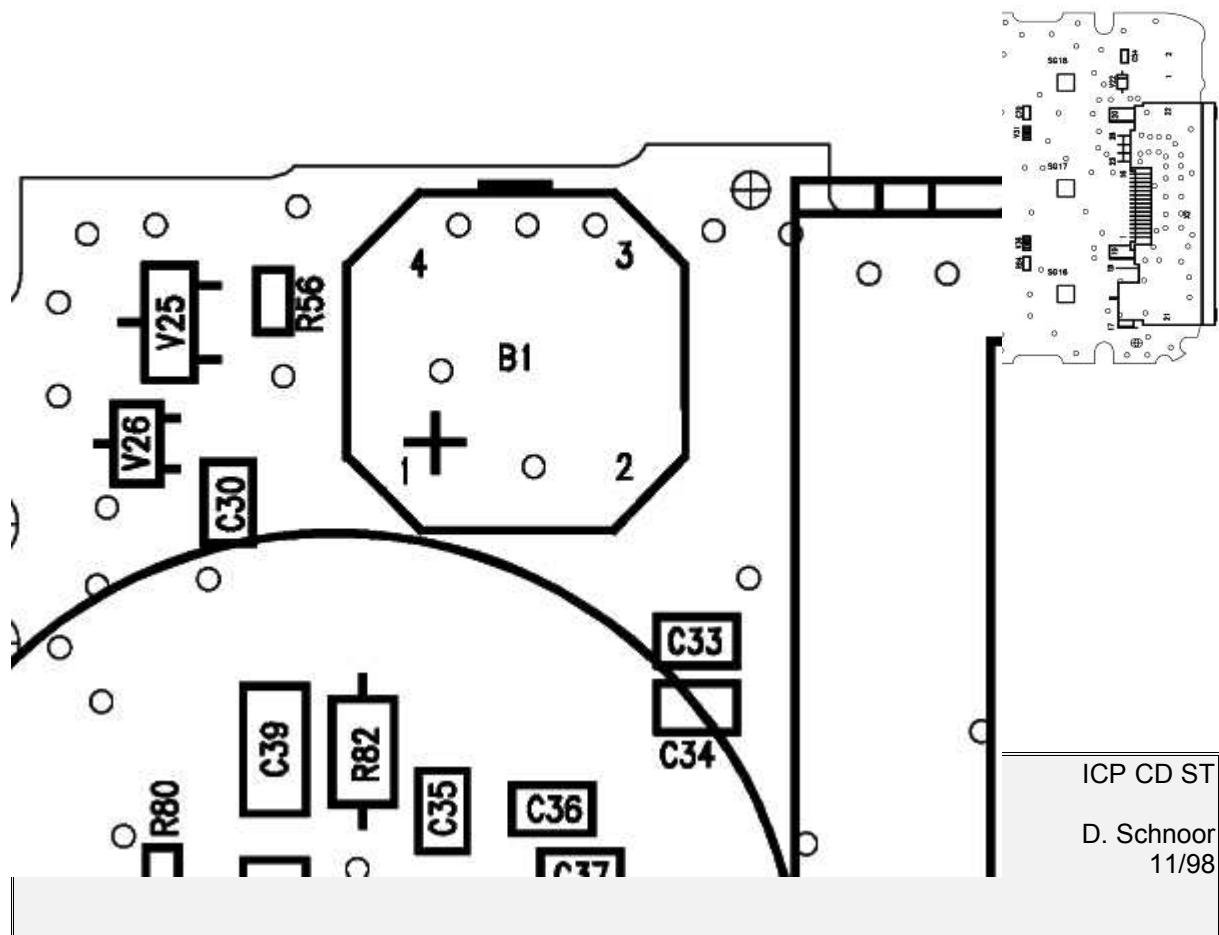
Figure 1: S10 / S10 active MMI Board Ringer Side

No ringer tone audible or ringer tone distorted.

Ringer check fails.

Use hot air blower remove defective ringer.
Avoid excessive heat!
Watch surrounding components, especially the display window!
To protect the display, you can also desolder the ringer with solder wick.

Resolder new ringer afterwards.
Watch placement of ringer!

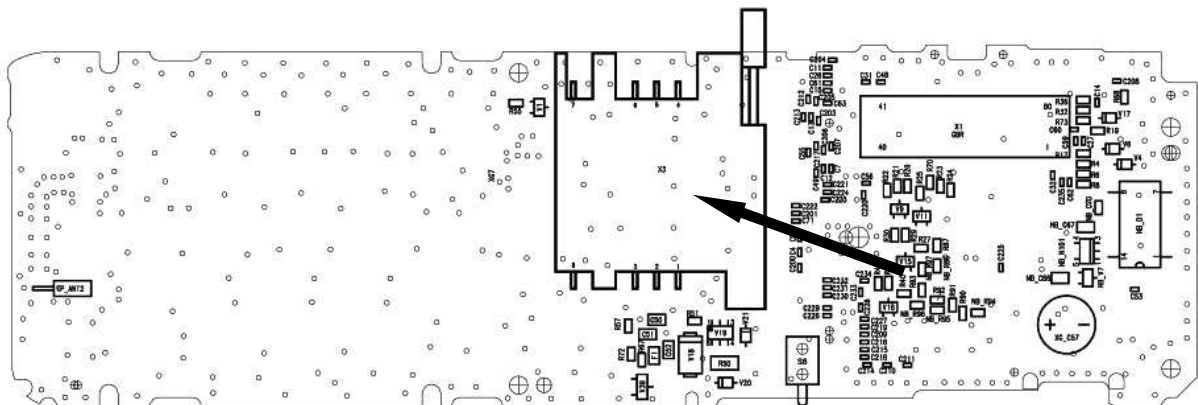
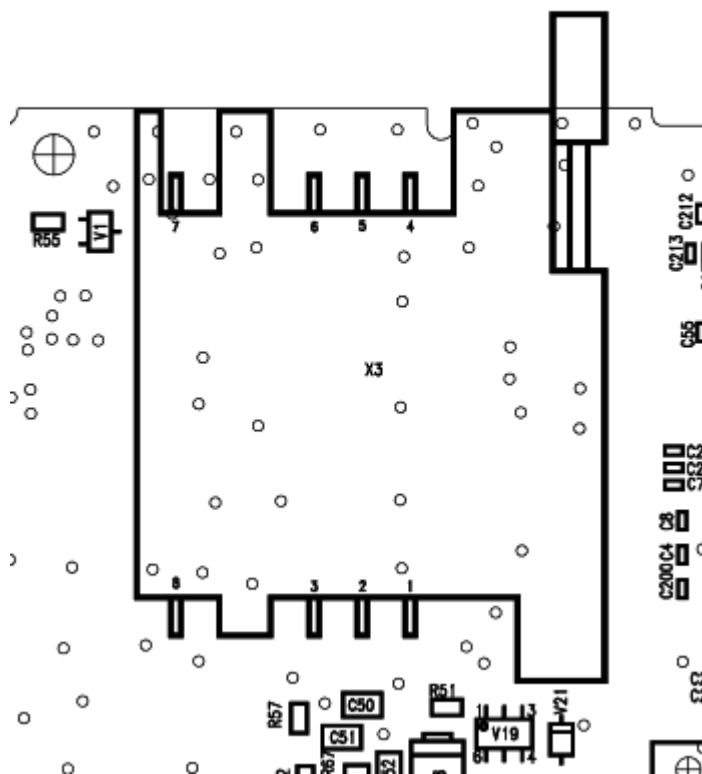
Figure 1: S10 MMI Board Cardreader Side

Sim card is not accepted or properly read by the handset.
Sim card ejection mechanism may be damaged.

Check cardreader functionality with sim card.
Attention: Watch for dry joints (especially pin 7!) or mechanical damage.

Resolder dry joints.

If the cardreader is mechanically damaged use solder wick to remove defective component.
Avoid excessive heat!
Watch surrounding components!!

Resolder new cardreader afterwards.

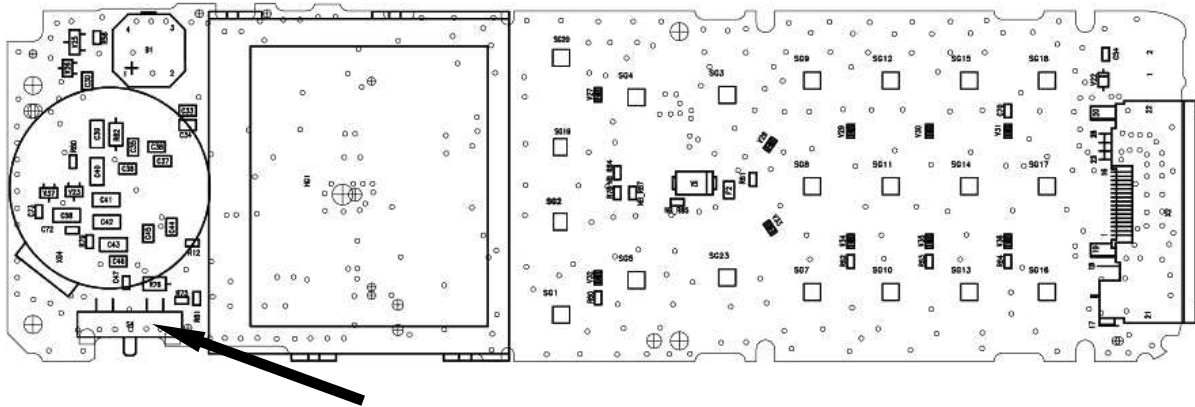
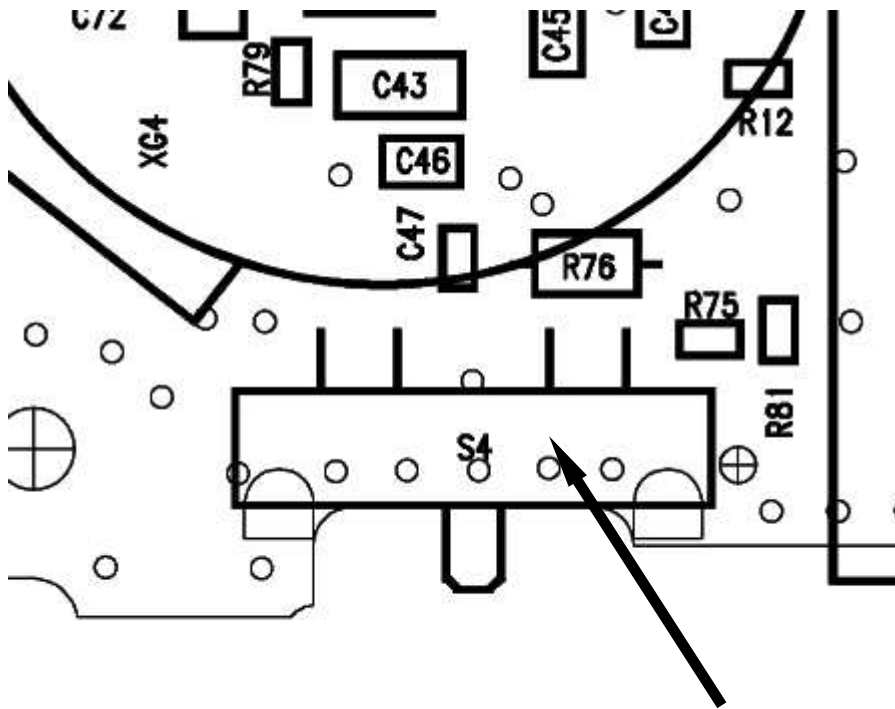
Figure 1: S10 / S10 active MMI Board Volumeslider Side

The volume slider does not work properly.

Check volumeslider functionality either manually or with the testing program.
Watch for dry joints or mechanical damage.

Use solder wick to remove defective slider.
Avoid excessive heat!
Watch surrounding components!!

Resolder new volumeslider afterwards.

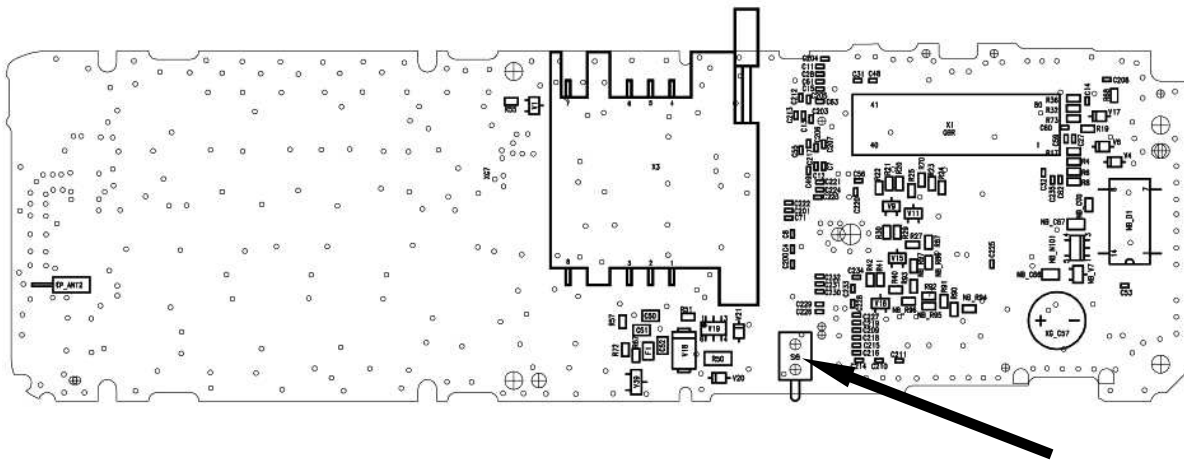
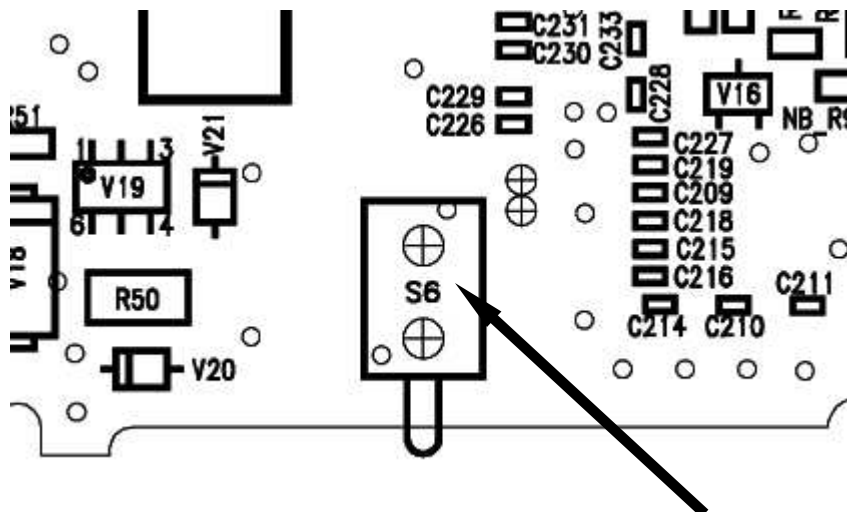
Figure 1: S10 / S10 active MMI Board Memoswitch Side

The memoswitch does not work properly.

Check memoswitch functionality either manually or with the testing program.
Watch for dry joints or mechanical damage.

Use solder wick or hot air to remove defective switch.
Avoid excessive heat!
Watch surrounding components!!

Resolder new memoswitch afterwards.

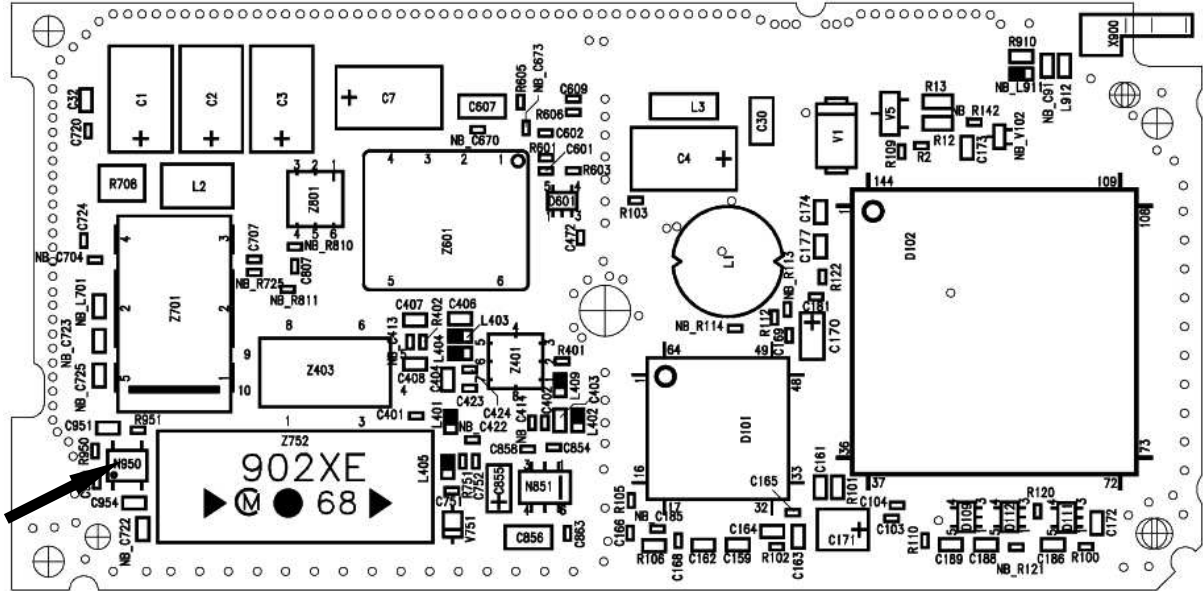
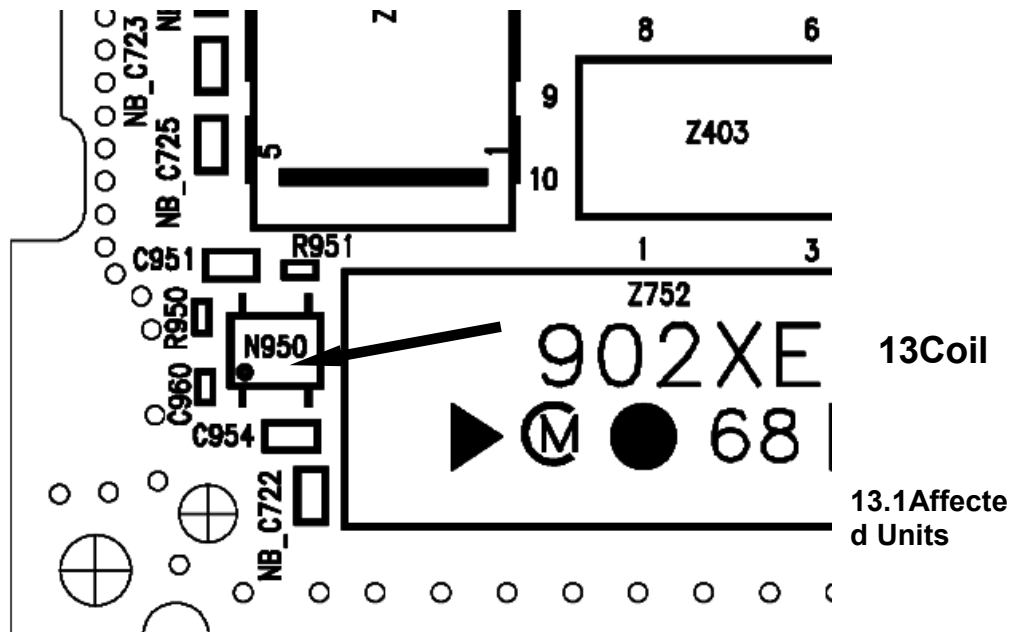
Figure 1: S10 / S10 active Board Antennaswitch Side

No Rx sensitivity and no location update possible.

Handset fails with low Tx power on both or either antenna.
No location update possible.

Pin 5 against ground must be around 50 kOhms.
Pin 1 against ground must be around 1 kOhm.

If any of these resistances are significantly lower (for example pin 5 around 17 Ohms) the antenna switch is defective and has to be replaced.

Use solder wick or hot air to remove defective switch.
Avoid excessive heat!
Watch surrounding components!!

Resolder new antennaswitch afterwards.

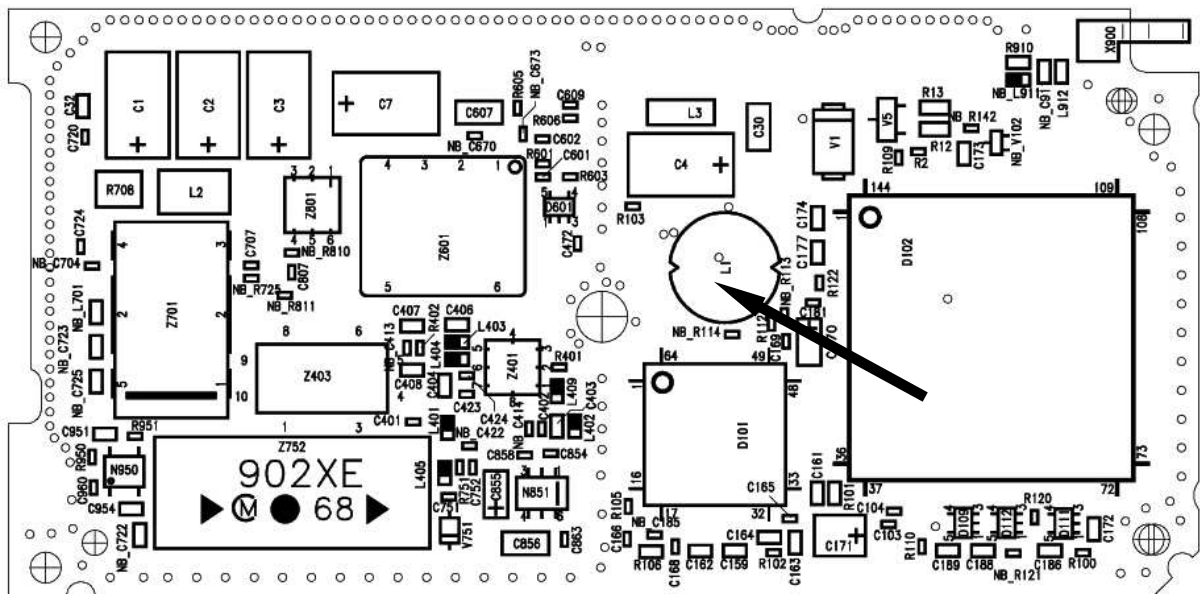
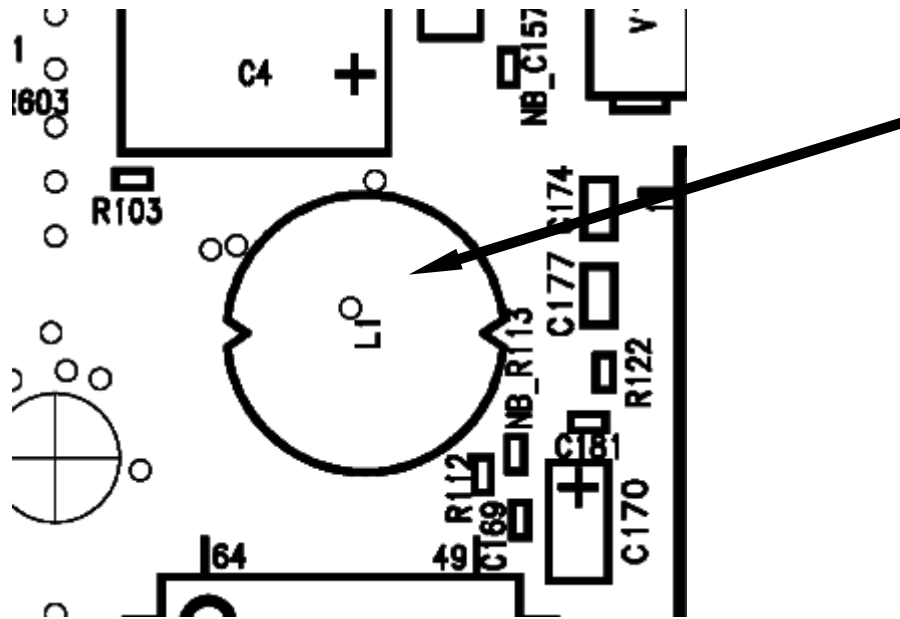
Figure 1: S10 / S10 active Board Coil (L1) Side

Loud humming noise in loudspeaker.

If the coil is mechanically damaged (broken) it produces heavy interference with the acoustical elements of the S10 resulting in a loud humming noise in the earpiece.

A broken coil can easily be diagnosed by trying to move it with two fingers. If it moves, the core is broken and the coil has to be replaced.

Use hot air to remove defective coil.
Avoid excessive heat!
Watch surrounding components!!

Resolder new coil afterwards
