S10 / S10 MMI

Repair Documentation

Level 2.5

V 4.4

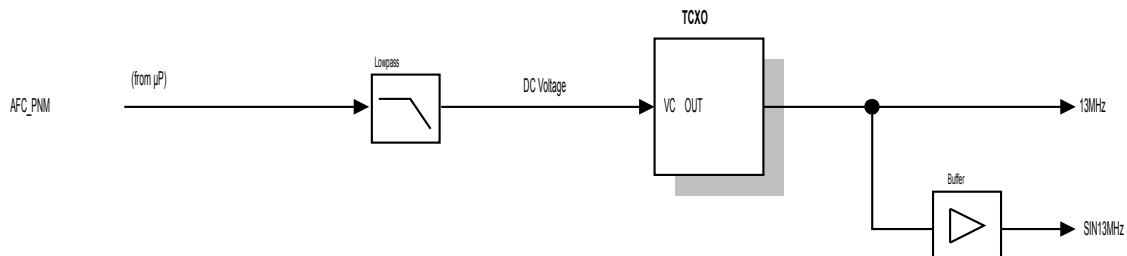
The TCXO (Temperature Compensated Crystal Oscillator) is responsible for generating the 13 MHz reference frequency of the handset. If it is defective, the handset cannot synchronize to the base station anymore.

All other frequencies are derived from this 13MHz reference, its stability is vital for the handset function.

The TCXO output frequency is determined by a DC tuning voltage applied to its VC pin. The voltage comes from the microprocessor as a pulse number modulated digital signal. A lowpass then converts this digital signal to a proportional DC voltage, which is then used to fine tune the TCXO output frequency.

If the frequency error is higher than 2kHz, the TCXO has to be replaced.

Use hot air blower to remove defective TCXO.
Avoid excessive heat!
Watch surrounding components!

Retest handset after repair as described above.
The frequency error must now be < 2kHz.

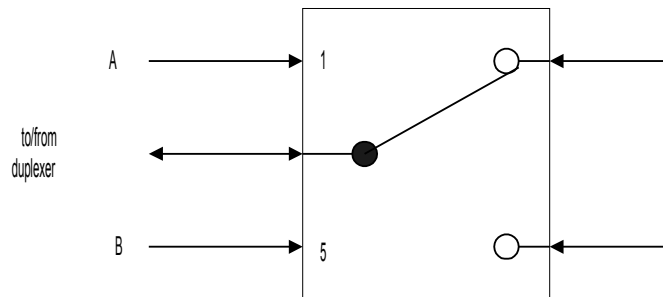
The antenna switch is used to switch the Rx and Tx path between the internal and external antenna of the handset

The switched path is determined by two digital inputs A and B (pins 1 and 5).
