Trouble shooting guide, Mechanical

Applicable for Z1010

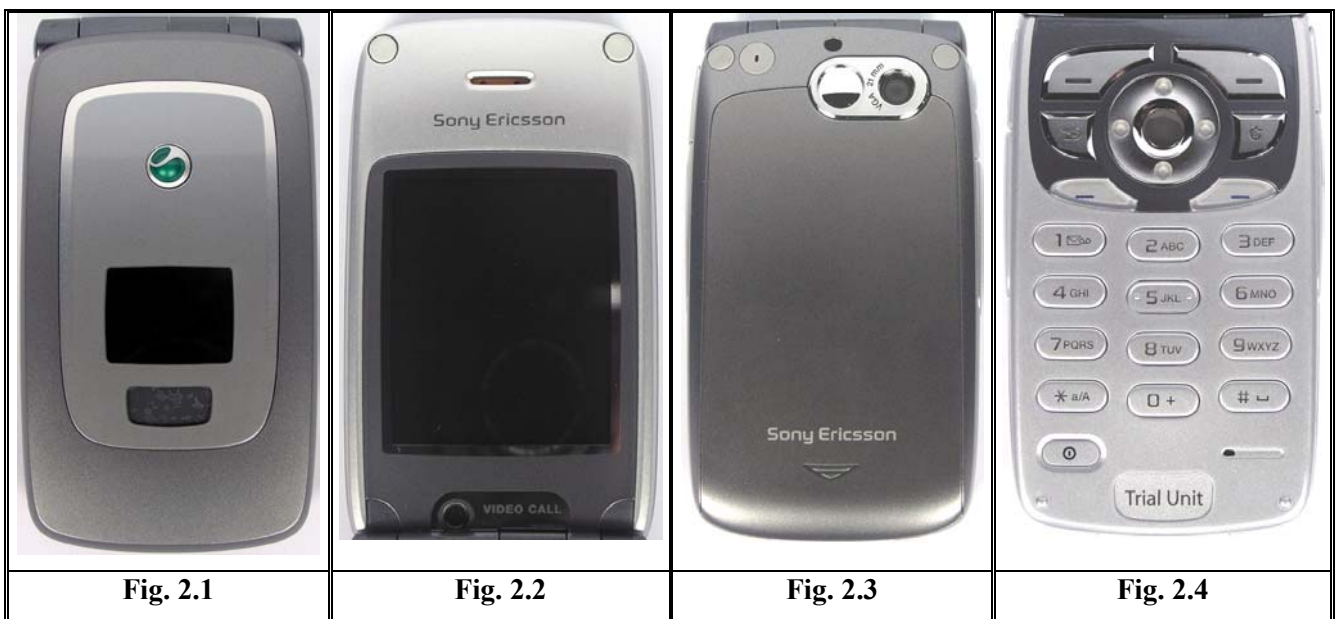
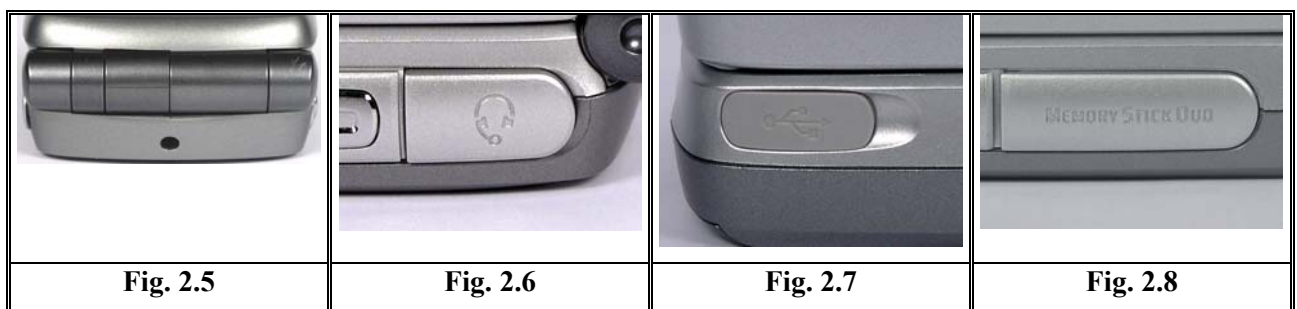
- Make a general visual inspection for corrosion and oxidation from liquid damage according to point 1.2
- Check the Upper Rear Cabinet (*Fig. 2.1*), the Upper Inside Cabinet (*Fig. 2.2*), the Lower Rear Cabinet (*Fig. 2.3*) and the Lower Inside Cabinet (*Fig. 2.4*) for damage, scratches and that the parts fit correctly. Replace the faulty components if necessary.

- Check the Keyboard (*Fig. 2.4*), the IMD plate (*Fig. 2.1*) and the SEMC Icon (*Fig. 2.1*) for damage, scratches and that the parts fit correctly. Replace the faulty components if necessary.

- Check the screw covers, the hinge covers (*Fig. 2.5*), the battery lid (*Fig. 2.3*), and the cover mirror camera (*Fig. 2.3*) for damage, scratches and that the parts fit correctly. Replace the faulty components if necessary.

- Check the cover audio jack (*Fig. 2.6*), the cover USB connector (*Fig. 2.7*), the cover MS duo connector (*Fig. 2.8*) and the cover ext. antenna connector (*Fig. 2.3*) for damage, scratches and that the parts fit correctly. Replace the faulty components if necessary.

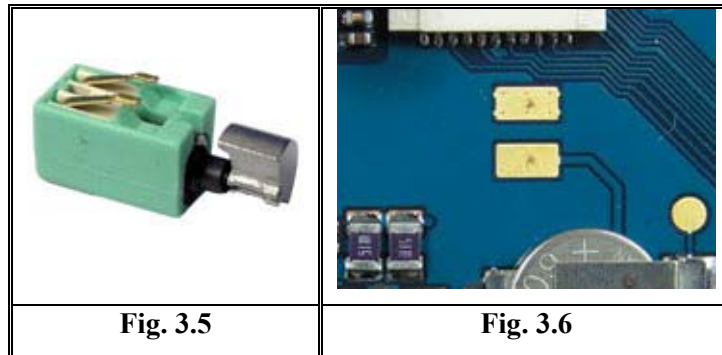
- Turn on the phone. Go to the service test menu; choose “Vibrator”. Press any key to check the vibrator works properly.
- Check if the vibrator (*Fig. 3.5*) is mechanically damaged, dirty or oxidized. Replace it if necessary.
- Check if the vibrator pads (*Fig. 3.6*) are dirty or oxidized. Clean them if necessary.

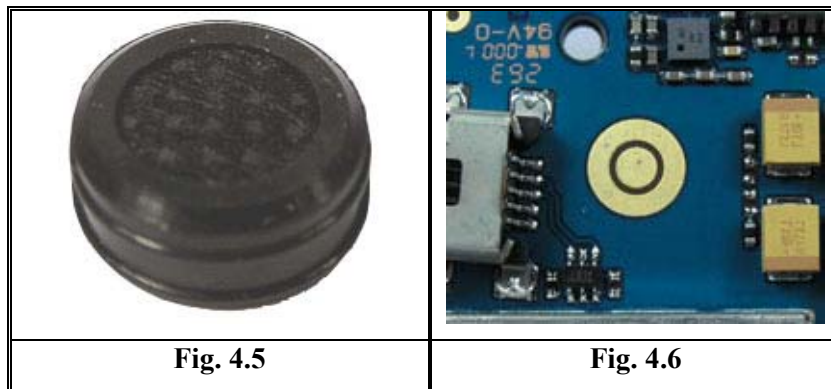
- Insert a working SIM card to the Z1010 and turn it on; make a call to the phone.
- Check if the microphone (*Fig. 4.5*) is mechanically damaged, dirty or oxidized. Replace it if necessary.
- Check if the microphone pads (*Fig. 4.6*) are dirty or oxidized. Clean them if necessary.

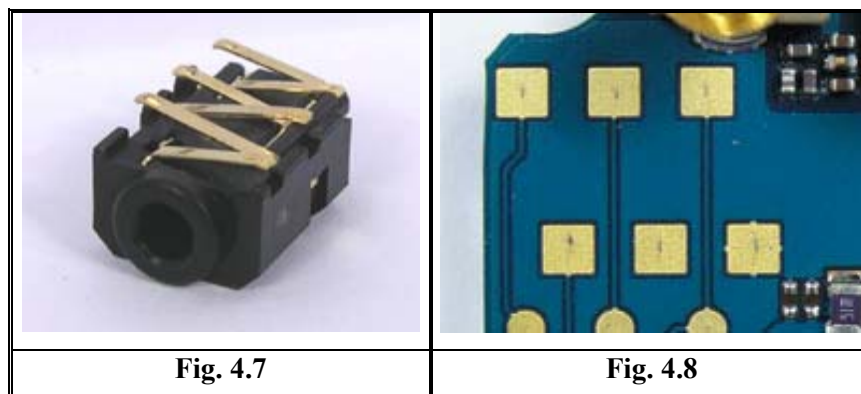
- Insert a working headset to the Audio jack connector.
- Insert a working SIM card to the Z1010 and turn it on; make a call to the phone.
- Check if there is sound from the earphone and that the microphone is working. Replace the Audio jack connector if necessary (*Fig. 4.7*).
- Check if the Audio jack pads on the Main PCB (*Fig. 4.8*) are dirty or oxidized. Clean them if necessary.

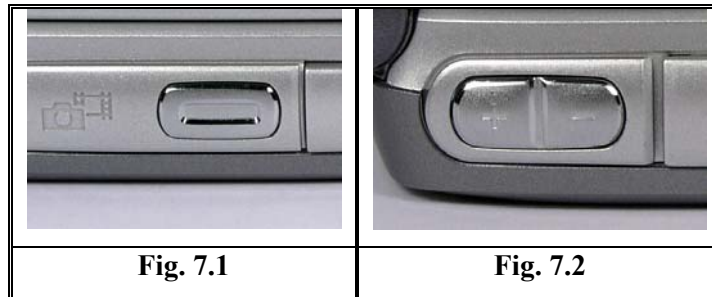
- Turn on the phone. Go to the service test menu; choose “Keyboard”. The pressed key will be indicated in the LCD.
- Check if the camera key (*Fig. 7.1*) and the volume keys (*Fig. 7.2*) are working properly and that the mechanical response feels normal. Replace keyboard (*Fig. 7.3*) if necessary.

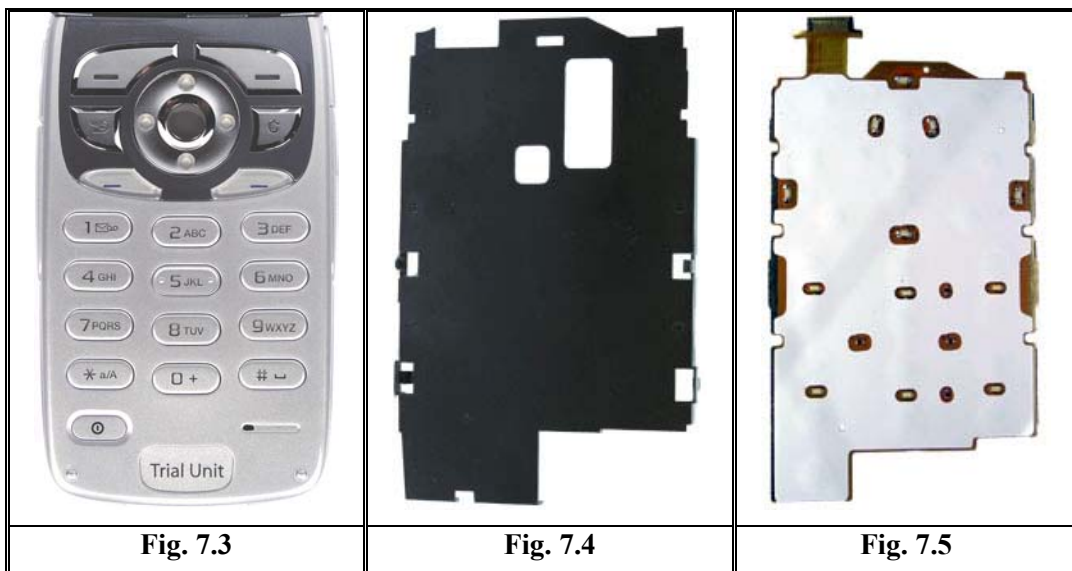
- Turn on the phone. Go to the service test menu; choose “Keyboard”. Press all the keys. The pressed key will be indicated in the LCD and a click is being heard.
- Check if the keyboard (*Fig. 7.3*) is working properly. Check if the mechanical response feels normal and that all the keys have been showed in the LCD. Replace the keyboard (*Fig. 7.3*), the keyboard support (*Fig. 7.4*) or the keyboard PCB (*Fig. 7.5*) if necessary.

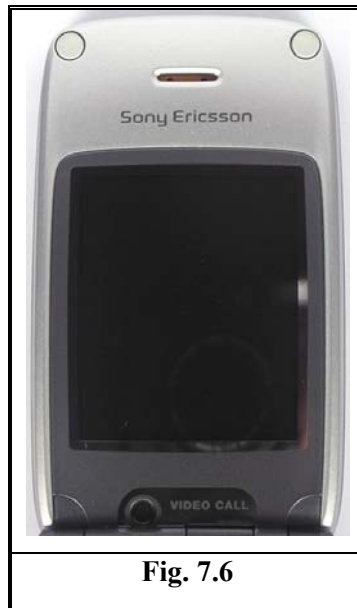
Fig. 7.6

- Insert a working SIM card into the Z1010 and turn it on and close the flip.
- Check if the Keyboard light turns off and the status LCD turns on. Replace the Upper inside Cabinet (*Fig. 7.6*) if necessary.
- Check if the upper and lower part of the phone fits tight together, when closing the flip. Replace the frame if necessary.

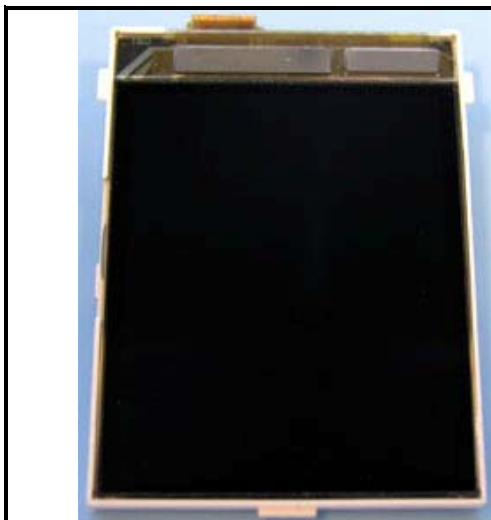
Fig 8.1

- Turn on the phone. Go to the service test menu; choose “Main screen”.
- Check if the main LCD (*Fig 8.1*) is working properly and if there are missing lines or discolours. Replace it if necessary.
- Check if the flex film (*Fig 8.4*) is mechanically damaged. Replace it if necessary.

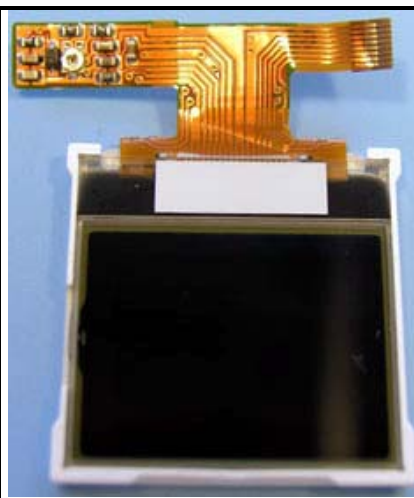
Fig 8.2

- Turn on the phone. Go to the service test menu; choose “External display”.
- Check if the status LCD (*Fig 8.2*) is working properly and if there are missing lines or rows. Replace it if necessary.
- Check if the flex film (*Fig 8.4*) is mechanically damaged. Replace it if necessary.

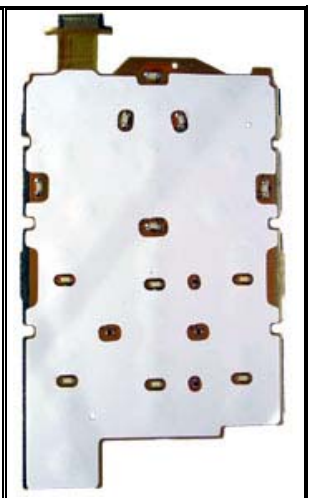
Fig 8.3

- Turn on the phone. Go to the service test menu; choose “LED/Illumination”.
- Check if the illumination is balanced all over the main LCD. Replace the main LCD if necessary.
- Check if the illumination is balanced all over the sub LCD. Replace the sub LCD if necessary.
- Check if the flex film (Fig 8.4) is mechanically damaged. Replace it if necessary.
- Check if the illumination is balanced in all the keys. Replace the keyboard PCB (Fig. 8.3) if necessary.

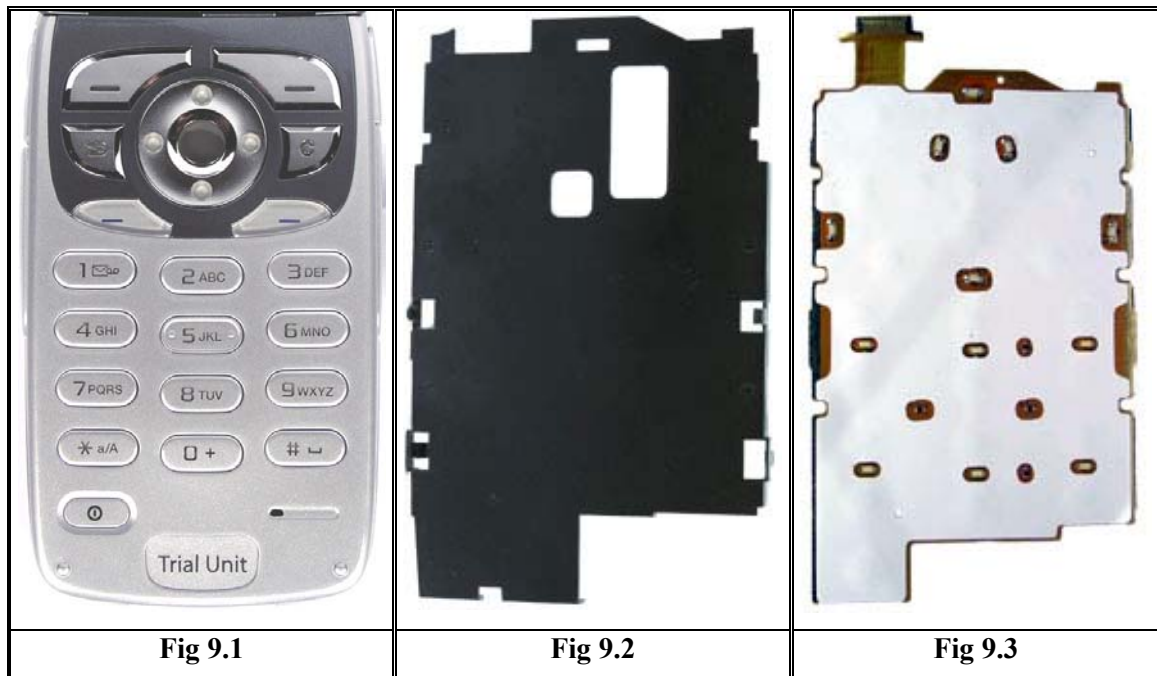
- Turn on the phone with a working battery. If it fails;
- Check if the On/Off key (*Fig. 9.1*) is working properly. Check if the mechanical response feels normal. Replace the keyboard (*Fig. 9.1*), the keyboard support (*Fig. 9.2*) or the keyboard PCB (*Fig. 9.3*) if necessary.

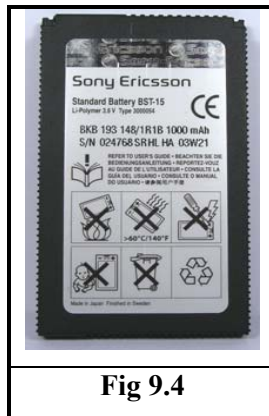
- Turn on the phone with the customer's battery. If it fails, connect a charger to the phone, if the battery voltage is too low the phone will charge the battery without turning on the phone (this will usually not take more than 10 minutes) and when the battery voltage is high enough the phone will be able to turn on and show charging in the LCD.
If it still fails to turn on;
- Check if the battery (*Fig. 9.4*) is not mechanically damage. Replace it if necessary.

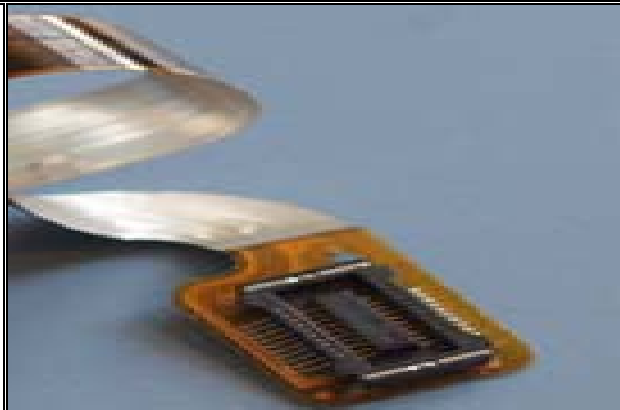
Fig. 10.5

- Turn on the phone. Go to the service test menu; choose “Video call camera”.
- Check if the CIF camera module (*Fig. 10.3*) works properly; verify the viewfinder functionality in the LCD. Replace it if necessary.
- Check if the CIF camera gasket (*Fig. 10.4*) is mechanically damaged. Replace it if necessary.
- Check if the PCB assembly (*Fig. 10.5*) is mechanically damaged or oxidized. Replace it if necessary.

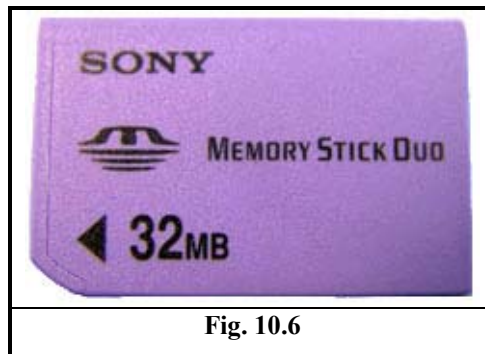
- Make a general visual inspection for corrosion and oxidation from liquid damage according to point 1.2
- Insert a working SIM card into the Z1010 and turn it on.
- Go to the file manager check if it is possible to copy or move some contents to the Memory Stick Duo.
- Check if a Memory Stick Duo (*Fig. 10.6*) fits correct into MS module. Replace the Memory Stick Duo if necessary.
