HTC Corporation	Doc. No.	DOC-00025733	REV.
	Issued Date	2008/1/15	A03
	Revised Date	2008/7/14	
Doc. Title	Melbourne Service Manual	Page	1 of 20

Melbourne

Service Manual

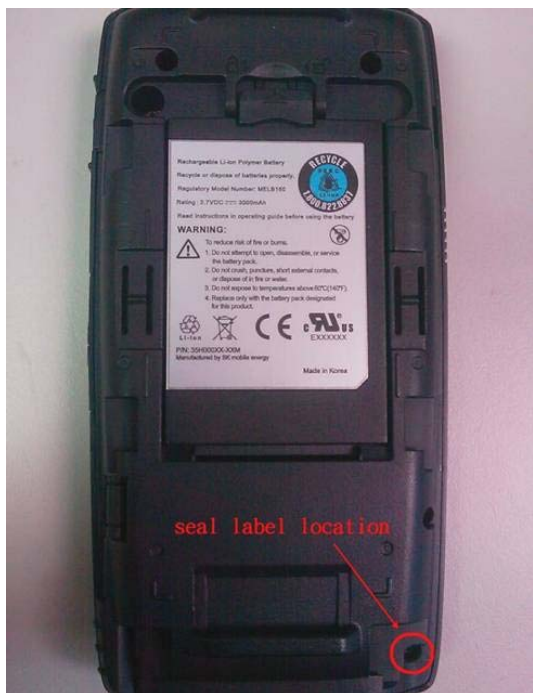
Location:

2.4 Tamper Evident Label

P/N: 77H00460-01M

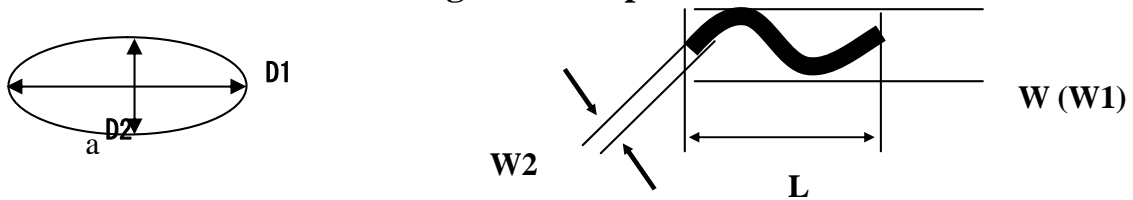
Definition:

D : diameter , W : width , L : length , S : separation

$$D = (D1 + D2) / 2$$

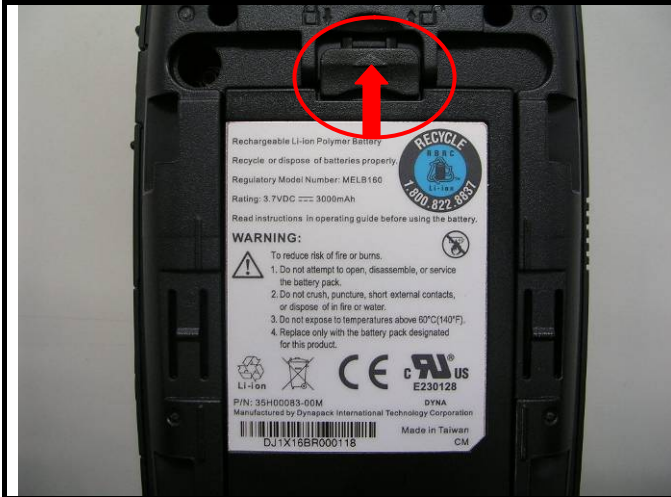
<p>Tools needed for Assembling and Disassembling.</p> <ol style="list-style-type: none"> 1. Lens Cleaning Tissue. 2. Plastic Knife. 3. Torex Screw Driver T5X40. 4. Philip Screw Driver 000X40. 5. Tweezers.(Suggest to use plastic made)
 	<p>Remove stylus.</p>
 	<p>Press battery cover with your two thumbs to move battery cover forward.</p>

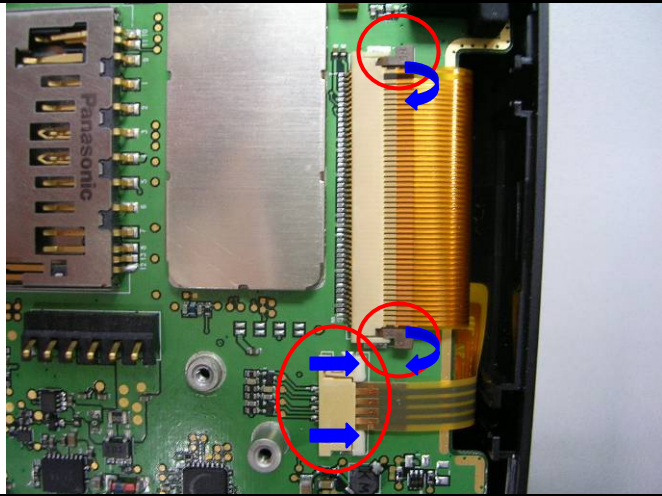
Remove one tape that paste on LCM FPC cable and touch screen FPC cable.

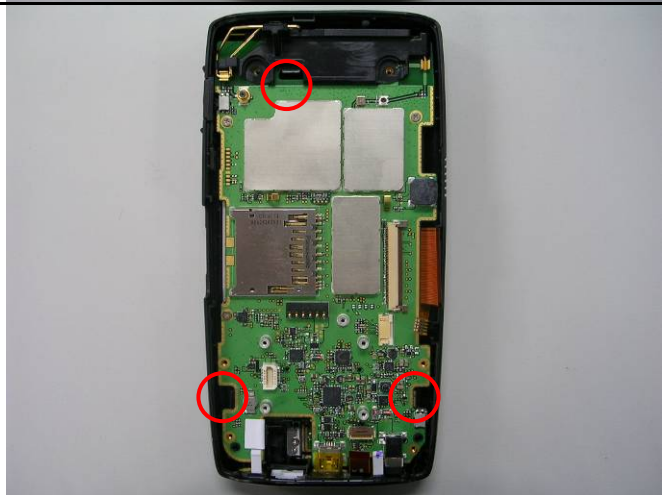
Unfasten three screws (M1.4*1.8*1.5).

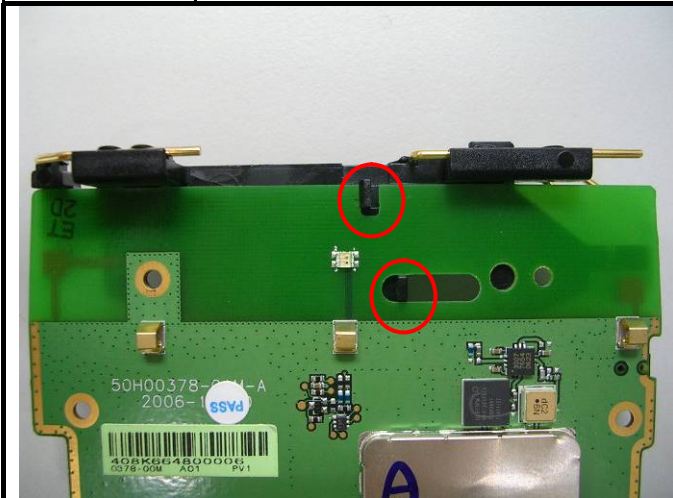
Use plastic stick to loosen three hooks and then take main board out from bezel.

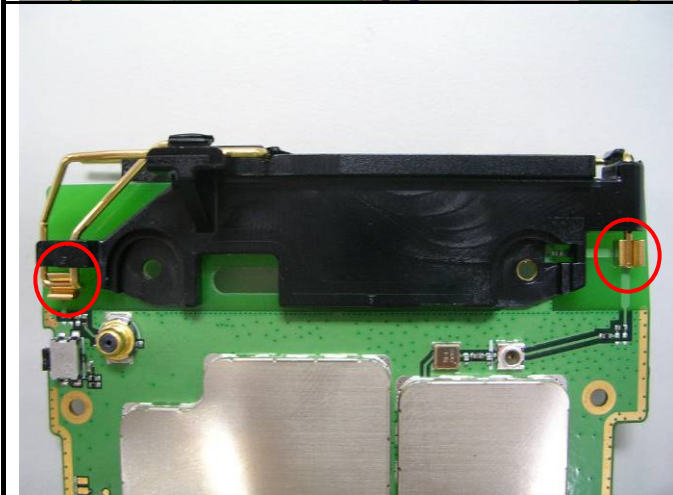
Loosen two hooks.

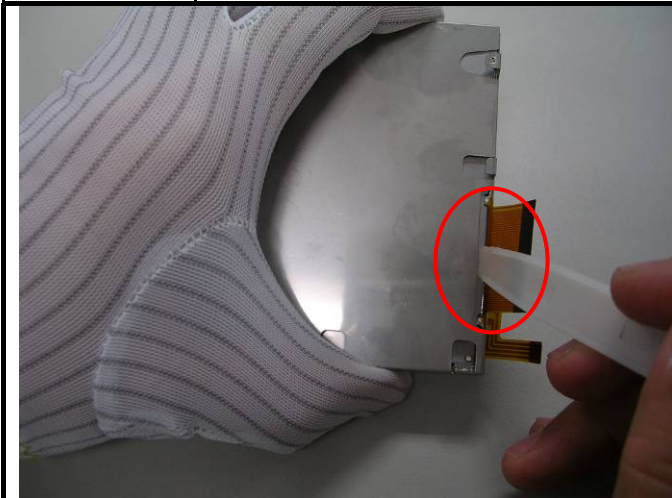
Use plastic stick to take LCM module with holder out.

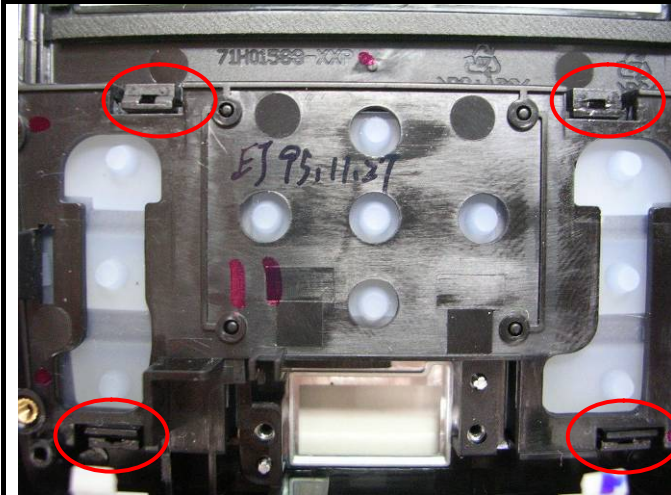
Assembly key pad module into the bezel and ensure four hooks that are locked completely.

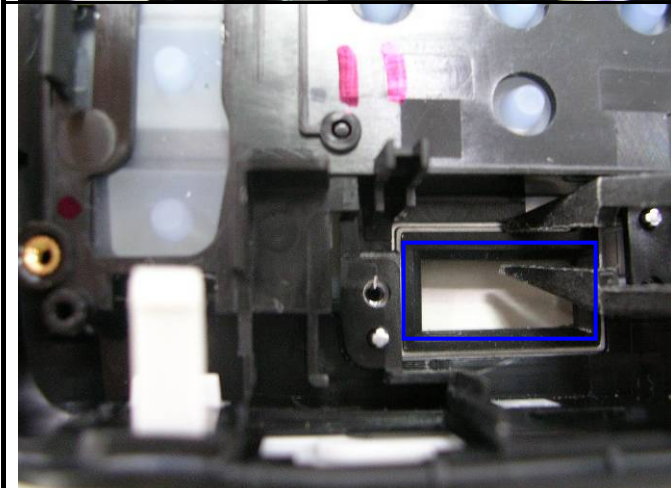
Use tweezers to place finger print rubber into the bezel.

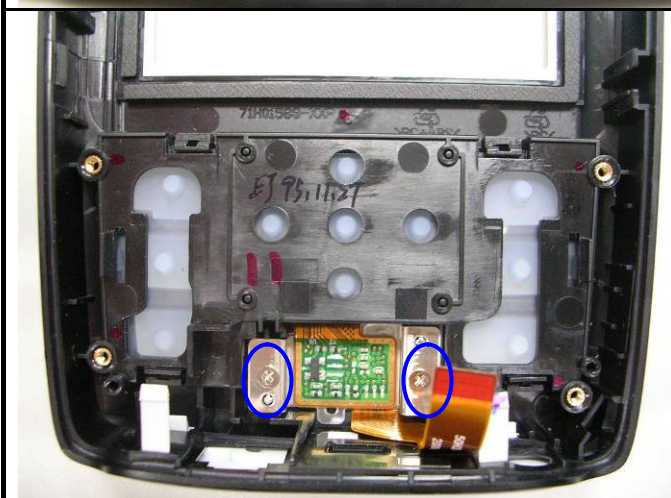
Place finger print module into the bezel and then fasten two screws.

Torque: 0.5 ± 0.1 kgf / cm²

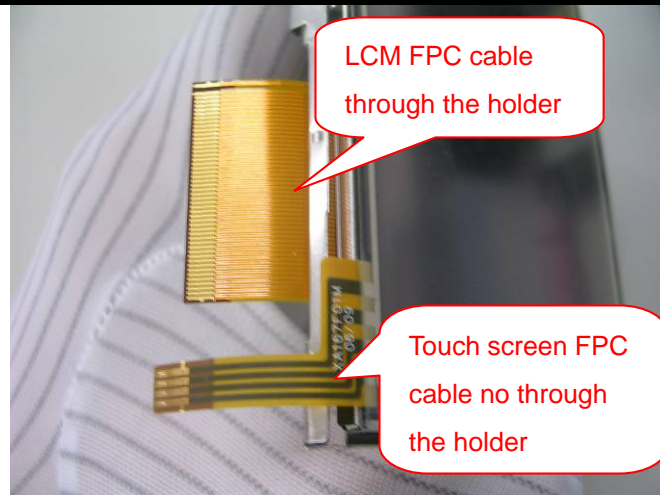
Place LCM module into the holder and ensure position of two cables correctly.

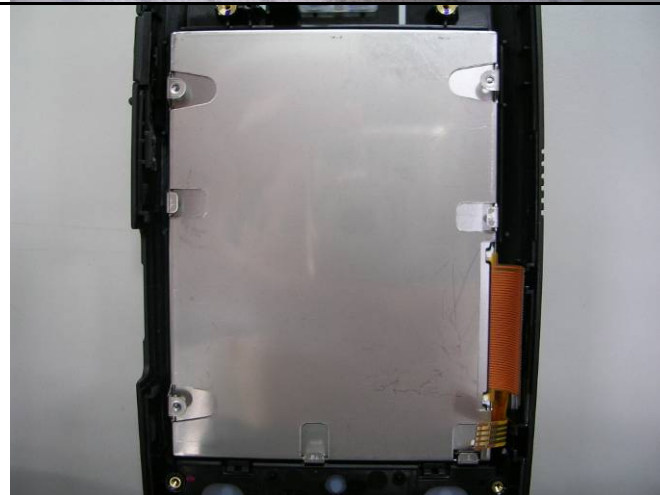
Place LCM module with holder into the bezel.

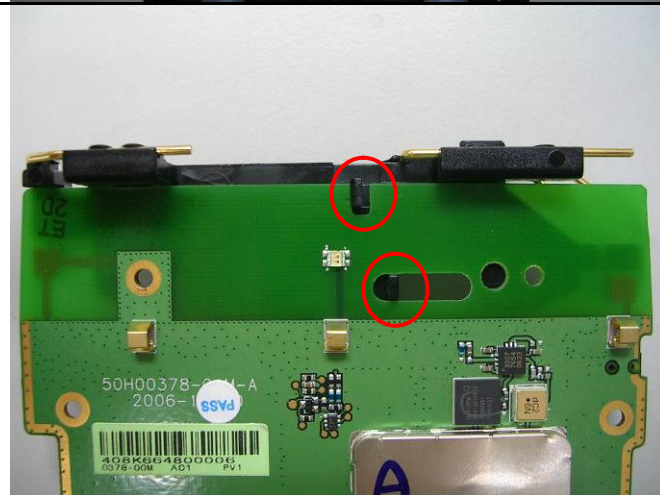
Assemble antenna module on main board and ensure two hooks are lock completely.

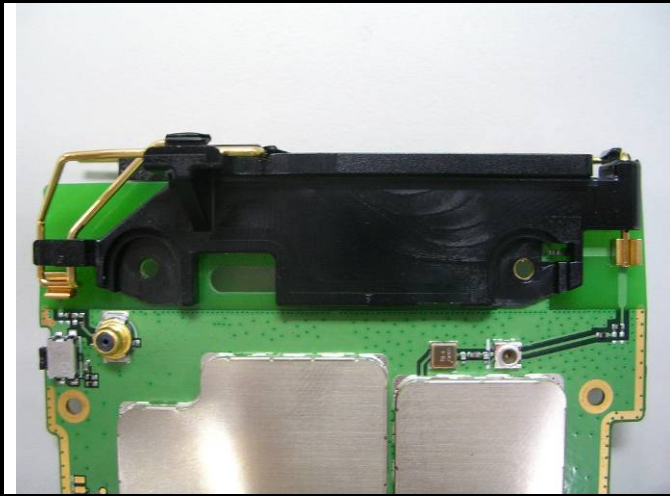
Ensure two metal sticks are locked completely.

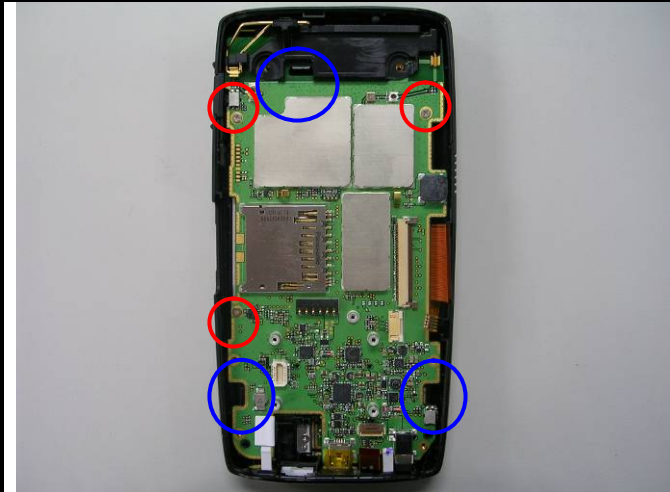
Place main board into bezel and ensure three hooks are locked completely then fasten three screws.

Torque: 0.3 ± 0.1 kgf / cm²

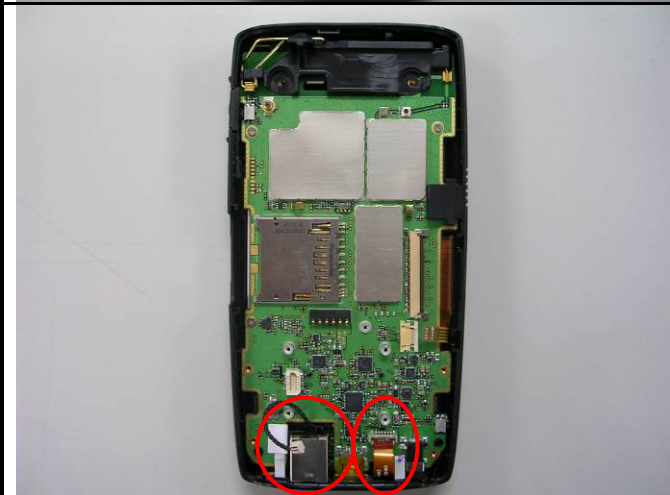
Place RJ11 connector into bezel and connect key pad cable.

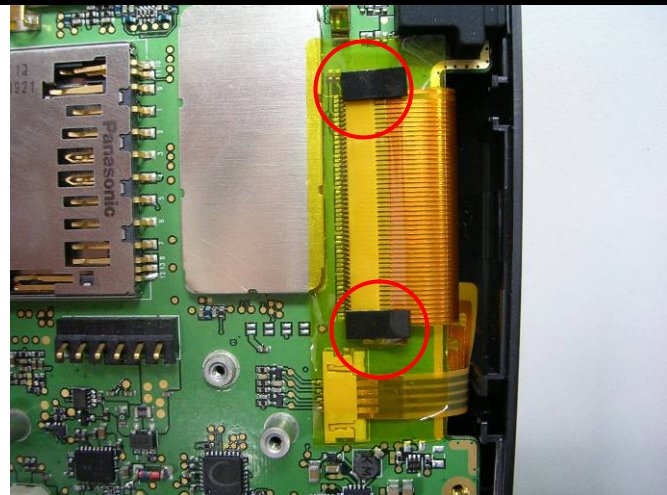
1. Connect LCM FPC cable and touch screen FPC cable.
2. Paste one yellow tape, two rubbers and ensure two rubbers are right upper two hooks.

Yellow tape P/N:76H01563-00M
Rubber P/N: 76H01703-00M

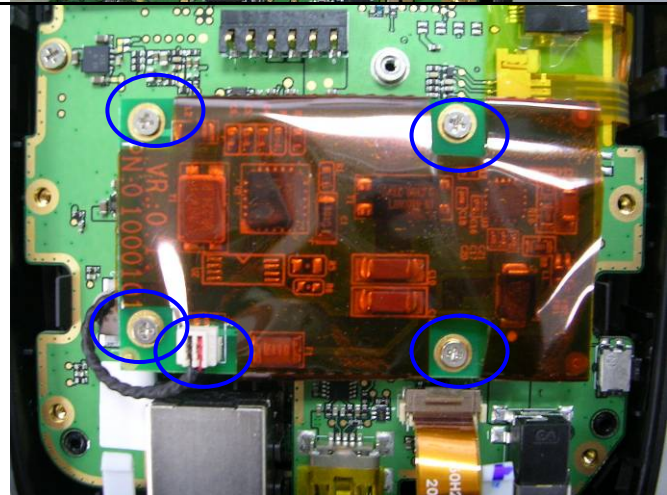
Assemble modem module on the main board, fasten four screws and connect cable.

Torque: $0.5 \pm 0.05 \text{ kgf / cm}^2$

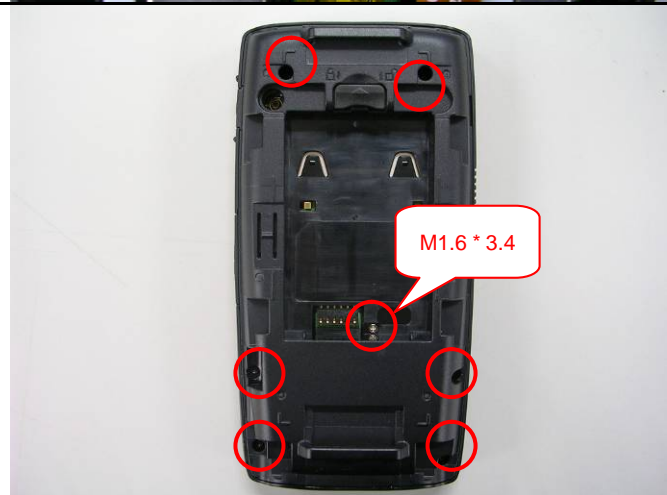
Combine bezel with housing and then fasten six screws (M1.6*6 mm) and one screw (M1.6*3.4).

Torque: $1 \pm 0.05 \text{ kgf / cm}^2$

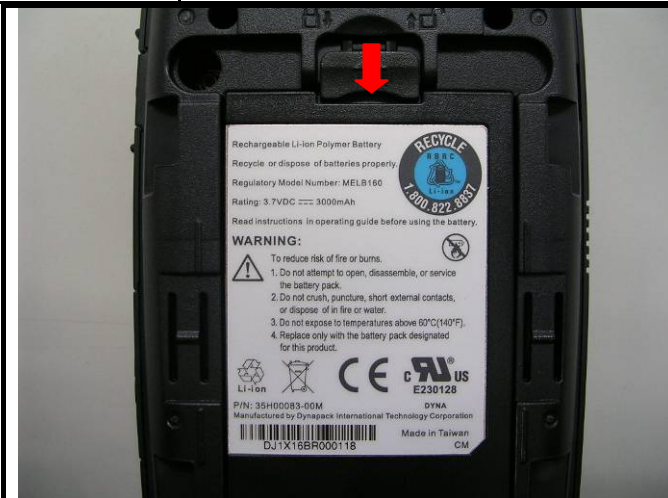
Place battery into housing and lock battery hook.

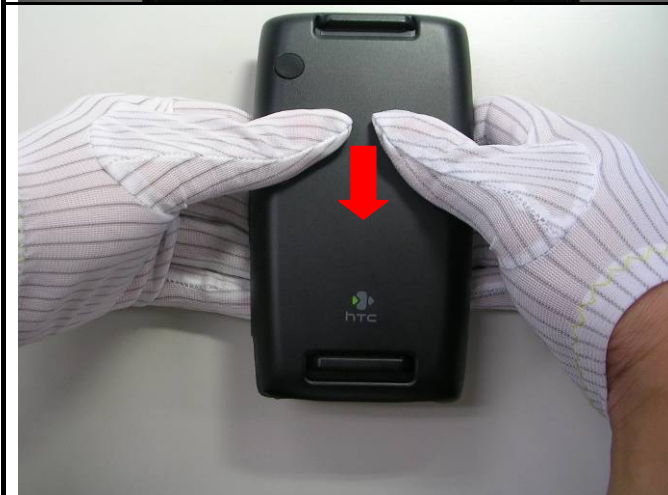
Assemble battery cover and insert stylus.

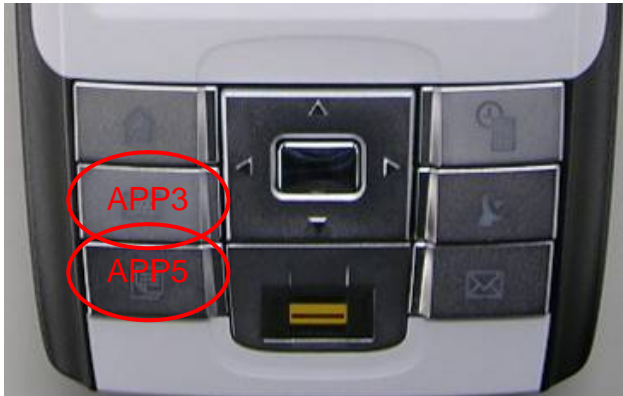
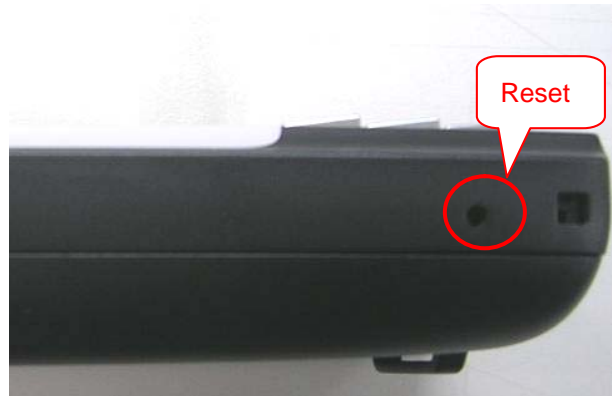
Boot loader mode: Press and hold APP5 + Reset

Cold boot: Press and hold APP3 + APP4 + APP6 + Reset

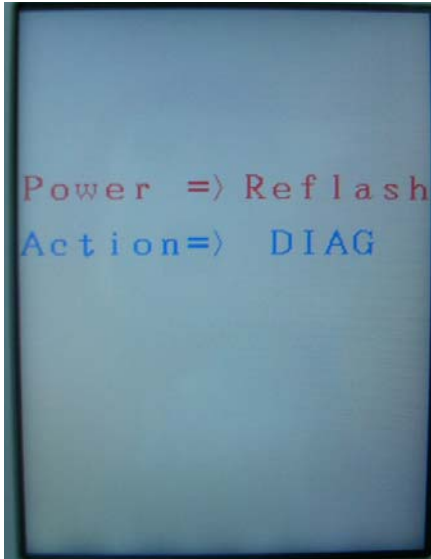
Step 3: Press power button to re-flash image. The re-flash process will perform about twenty minutes.

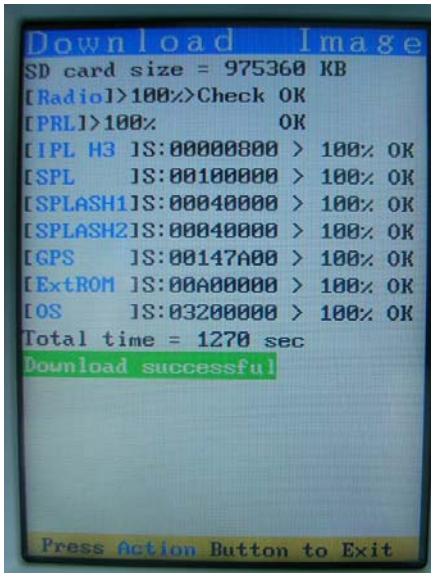
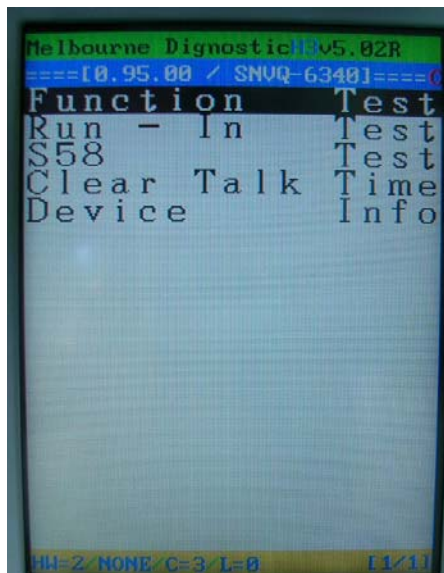
Step 4: After finishing the re-flash process, please press action button and then choice function test to check checksum.

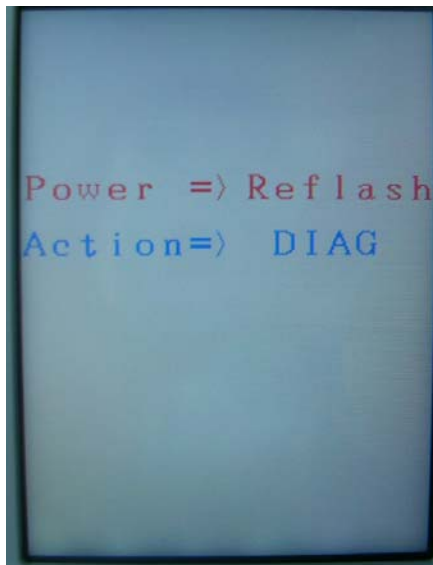
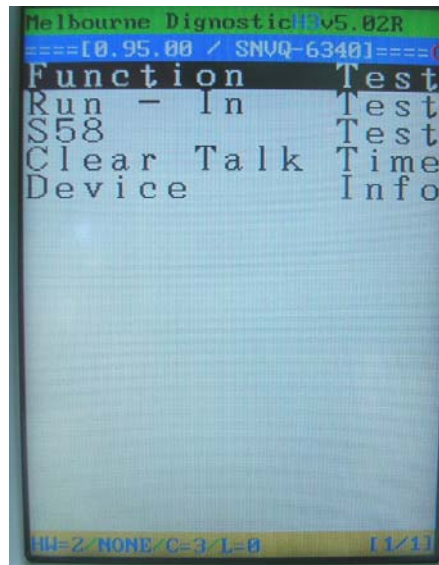
Step1: Please refer step 3 of OS upgrade process and then press action button to go into diagnostic mode.

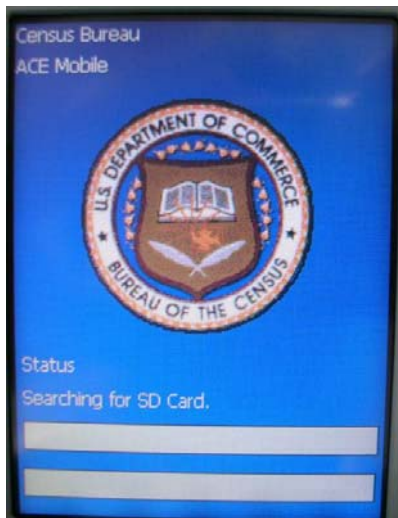
Step 2: Power on the device. The device will stop at searching for SD card.

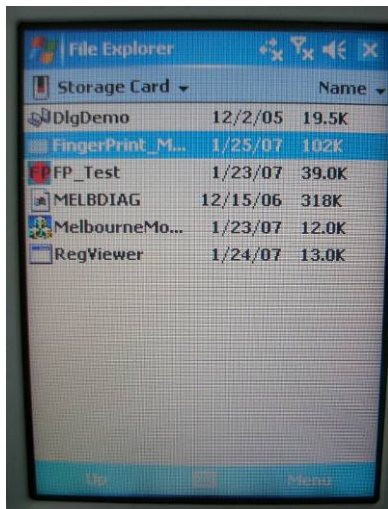
Step 4: Execute FingerPrint_ModemTest.exe program in storage card.

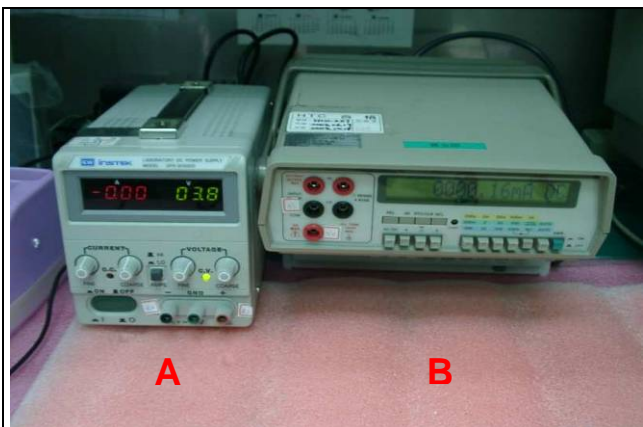
This is a quick method to measure if any abnormal leakage current on main board which caused high power consumption compare to GOOD main board.

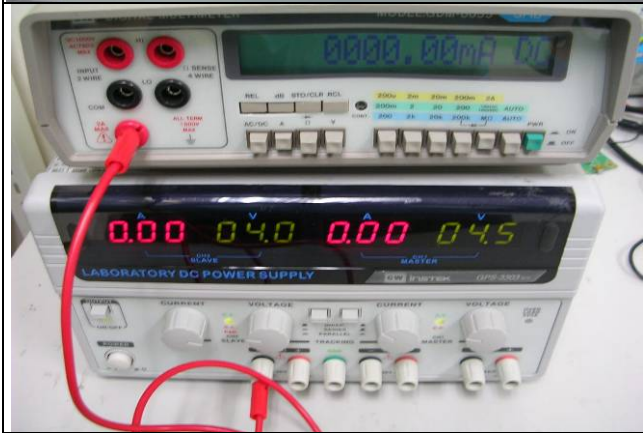
Fixture :

- C. Current series jig.(with black and red cable).
- D. Cable.
- E. Battery with extension cable.

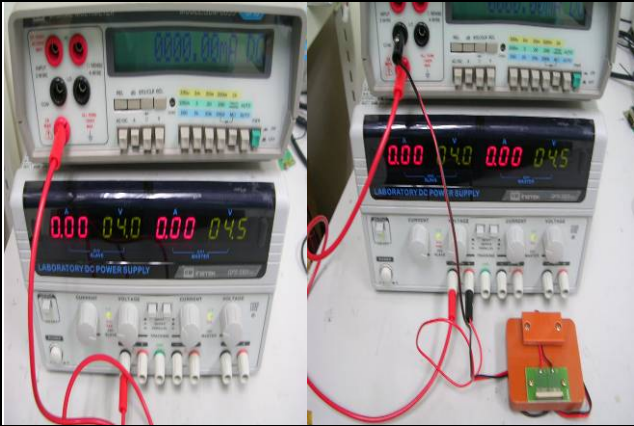
Connect cable (D) to positive polarity of power supply (A) and current meter (B).

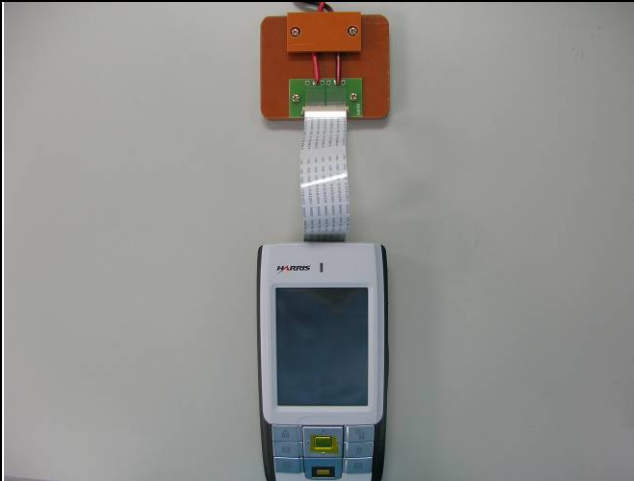
Connect cable of fixture (C) to negative polarity of power supply (A) and current meter (B).

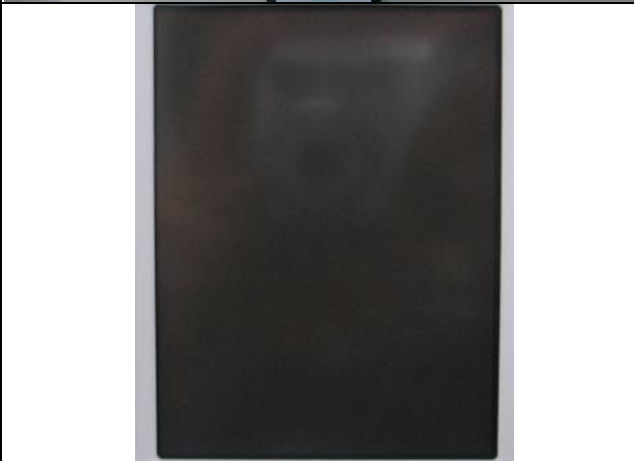
Setting is Ready now for testing.(Don't turn the power on at this moment)

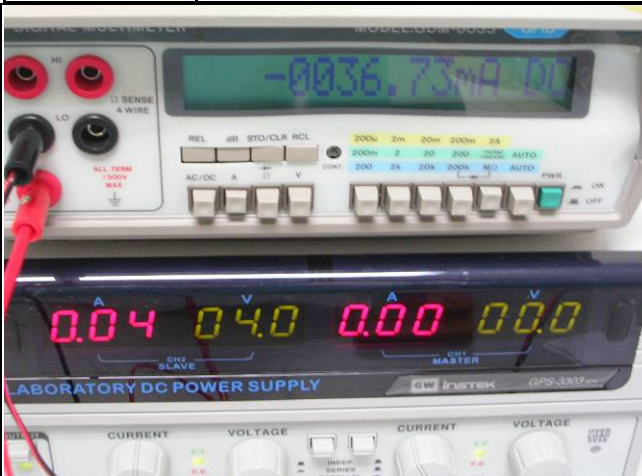
Turn on power supply (4V) and current meter (2A). Unit is still turned on but no LCD back light

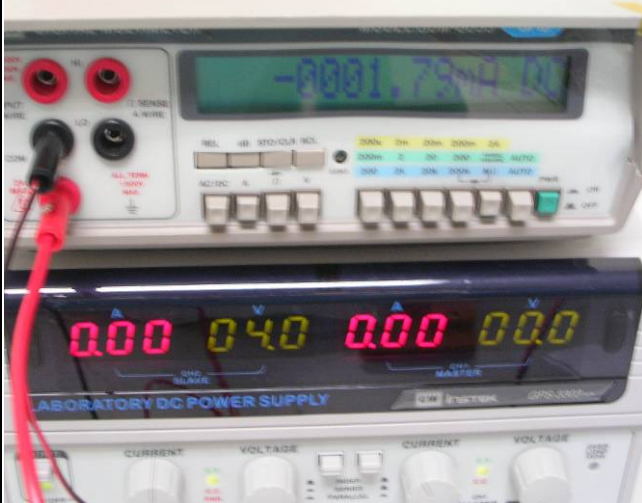
Measure Idle mode current. Current value must under 50mA, if over, it means M/B failed, please replace M/B for repair.

Switch OFF the unit. Unit is turn off and no display. Measure power off current check current value on the current meter, current value must less than 4 mA, if over, it means M/B failed, please replace M/B for repair.

If current consumption is passed at both of idle mode, it means M/B is GOOD. If there is any item FAILED at idle mode, it means M/B is failed, please replace M/B for repair.

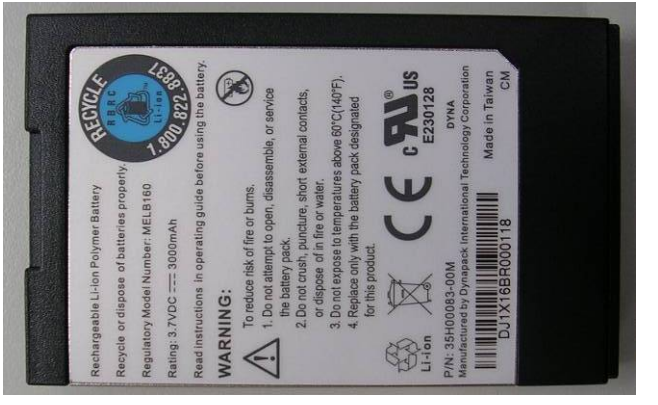
Part No	35H00083-02M

Description	BATTERY_LI-POLYMER, 3000mAh,3.7V	
Q'ty	1

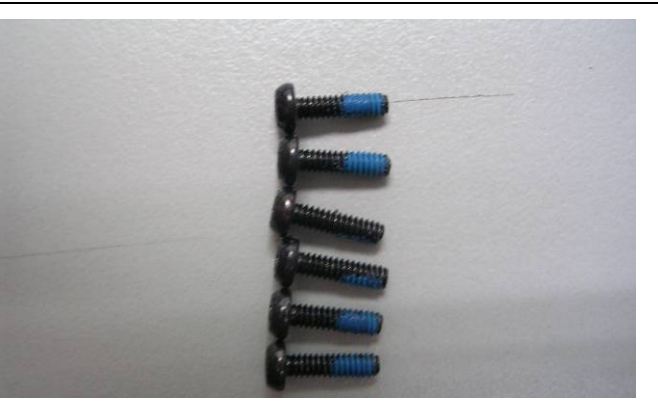
Part No	72H30037-01M

Description	Screw,PT,P,M1.6*6 mm, Coating with Ni & Nylok	
Q'ty	6

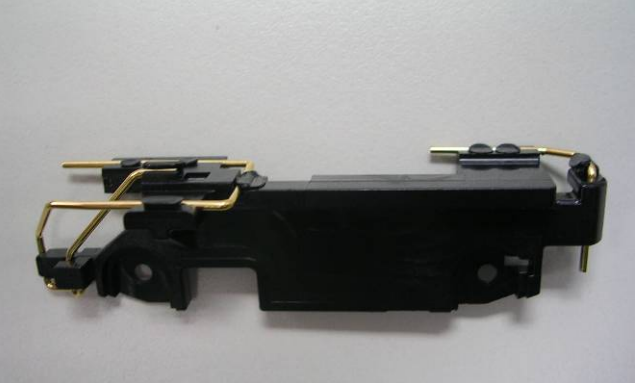
Part No	36H00470-00M

Description	Antenna,ACON,AMM00-000 00	
Q'ty	1

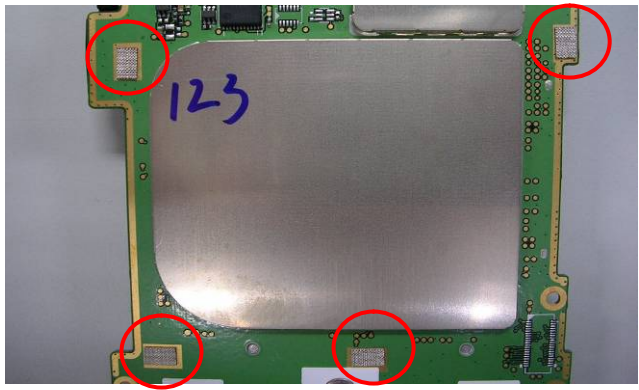
Part No	72H01669-00M

Description	EMI Gasket,5*3*0.5mm	
Q'ty	4

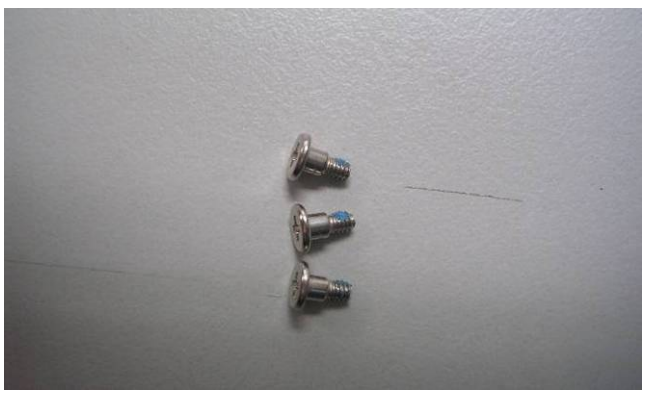
Part No	72H01585-00M

Description	Screw, with Nylok, M1.4*1.8*1.5, PH, POINT SCREW	
Q'ty	3

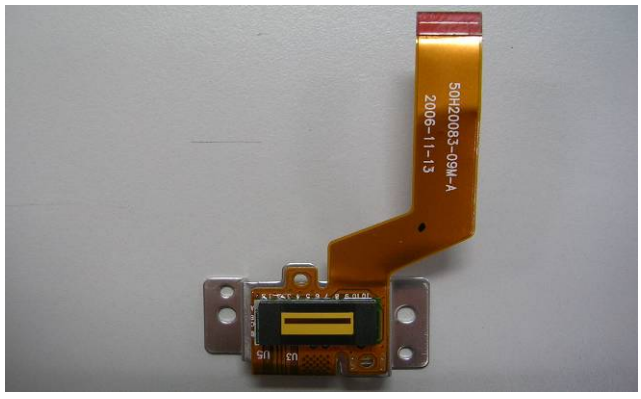
Part No	73H20083-09M

Description	FPC Pre-Assy, CAREER, Finger print	
Q'ty	1

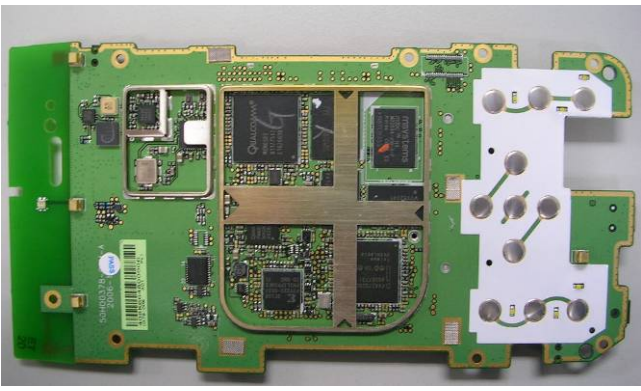
Part No	51H00378-00M

Description	PCBA-MAIN BOARD, Melbourne	
Q'ty	1

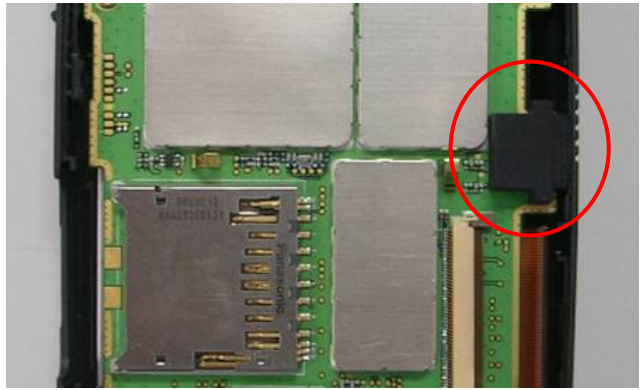
Part No	76H01430-00M

Description	Rubber, PCEC, Buzzer	
Q'ty	1

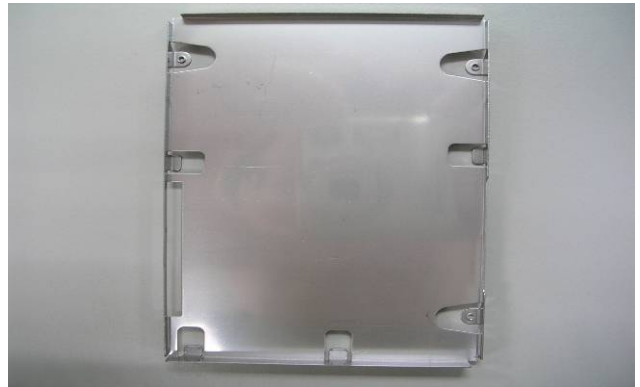
Part No	72H01582-00M

Description	Holder, LCD	
Q'ty	1

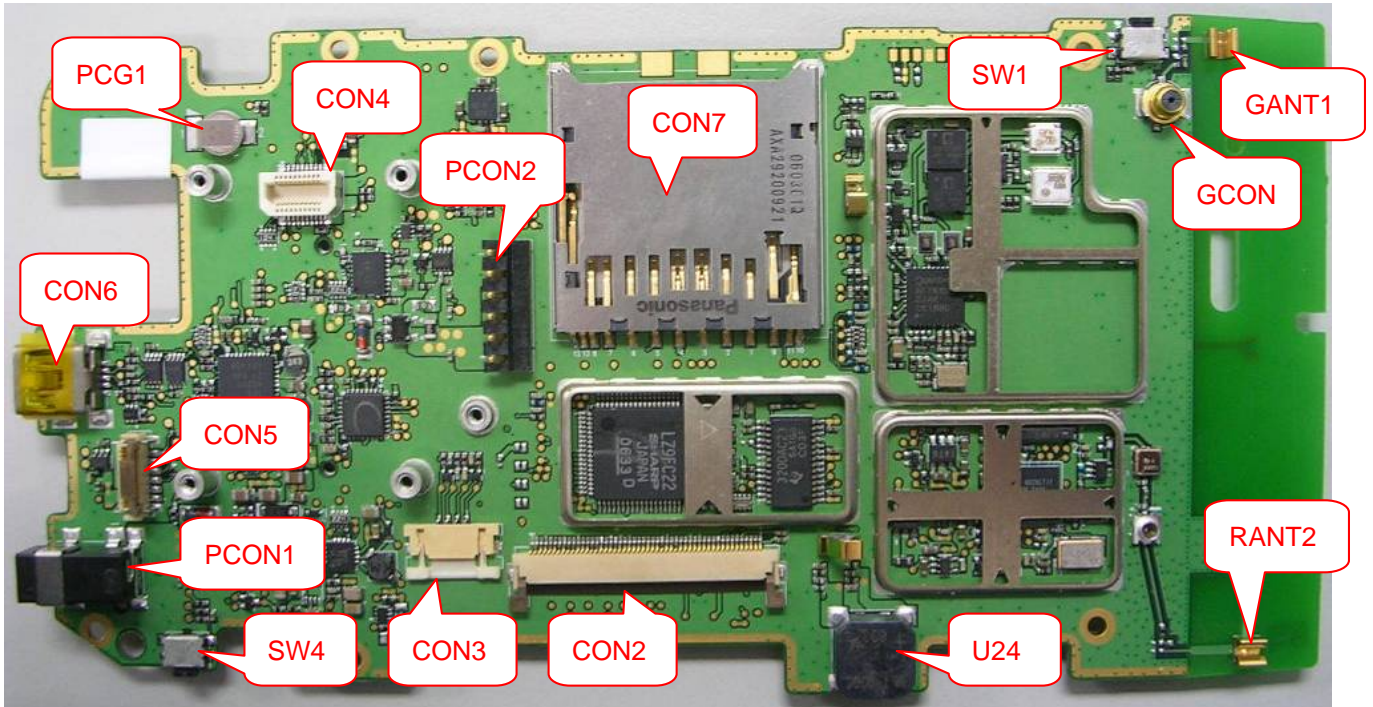
- Location of component and list

P/N	Description	Quantity	Location
16H00012-00M	Gold Cap,0.07F,70ohm,3.3V,-25/+50%,XH414H I102E,SEIKO,7.6*4.8*1.72mm,,70/-25degC	1	PCG1,
36H00129-00M	SWITCH BUTTON,PTS-106,HCH,4.7*4.5*1.65,70/-20degC,BLUE ANGELS	2	SW1,SW4,
36H00300-00M	Fuse,046702.5,2.5A/32V,LITTLEFUSE,Apache	3	PF1,PF2,PF3,
36H00450-00M	Buzzer,8.5*8.5*4.0mm,STAR,MLT-03GC	1	U24,
36H00485-00M	DC Jack,SINGATRON,2DC-S061-I01	1	PCON1,
75H00152-00M	Connector FPC,0.5A,50V,50P,0.5mm Pitch,FH12A-50S-0.5SH(55),HIROSE	1	CON2,
75H00248-00M	COAXIAL CONNECTOR,RF,WITH SWITCH,SMD,MM8430-2600RA1,MURATA	1	GCON,
75H00269-00M	Connector SD Card,AXA29200921,SDIO CONNECTOR,13PIN,MATSUSHITA	1	CON7,
75H00279-00M	Connector Device(Battery),AXB79300602,6Pin,2.5Pitch,MATSUSHITA	1	PCON2,
75H00321-00M	Connector RF,4P,LPC TP-1,120220-0129,ITT Cannon,Pb-FREE	1	RSW1,
75H00379-00M	Connector I/O,Mini USB AB,5P,0.8Pitch,1A,30V,67803-8040,MOLEX	1	CON6,
75H00453-00M	Connector Antenna Clip,1P,GT417001EU,AMPHENOL	2	GANT1,RANT1,

75H00496-00M	Connector FPC,DELL,4P,1Pitch,04(1.0)9FLH-SM1-GB(LF)(SN),JST,0.5A,50V,60mohm	1	CON3,
75H00544-00M	Connector B to B,20P,0.5Pitch,AXK5S20037YG,MATSUSHITA	1	CON4,
75H00545-00M	Connector FPC,12P,0.5Pitch,FH12-12S-0.5SV(55),HIROSE	1	CON5,

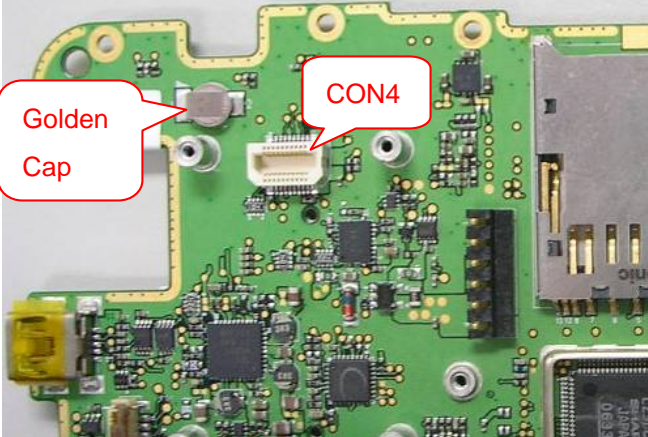
Notification

<p>Golden cap is easy to be damage during board level repair. Before replacing CON4, please remove Golden Cap first and never re-use original Golden Cap. Please replace new one.</p> <p>The temperature of solder iron must be less than 350 degrees and heating time must be within 5 seconds.</p>
<div style="display: flex; justify-content: space-around;"> <div data-bbox="148 882 426 1207">

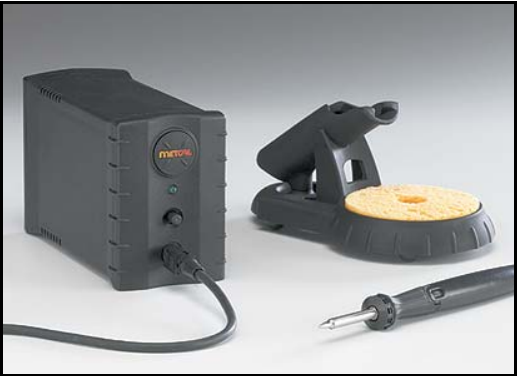
<p>PS-800</p> </div>	<ol style="list-style-type: none"> 1. For lead-free hand soldering is being able to solder heat sensitive components (the melting point of solder joint: 215-220 °C), without causing damage. 2. It allows the higher temperature requirements of lead-free alloys to be met without increasing the tip temperature. Thus, the risk of thermal damage is eliminated. 3. Checking list for regular functional checkup.

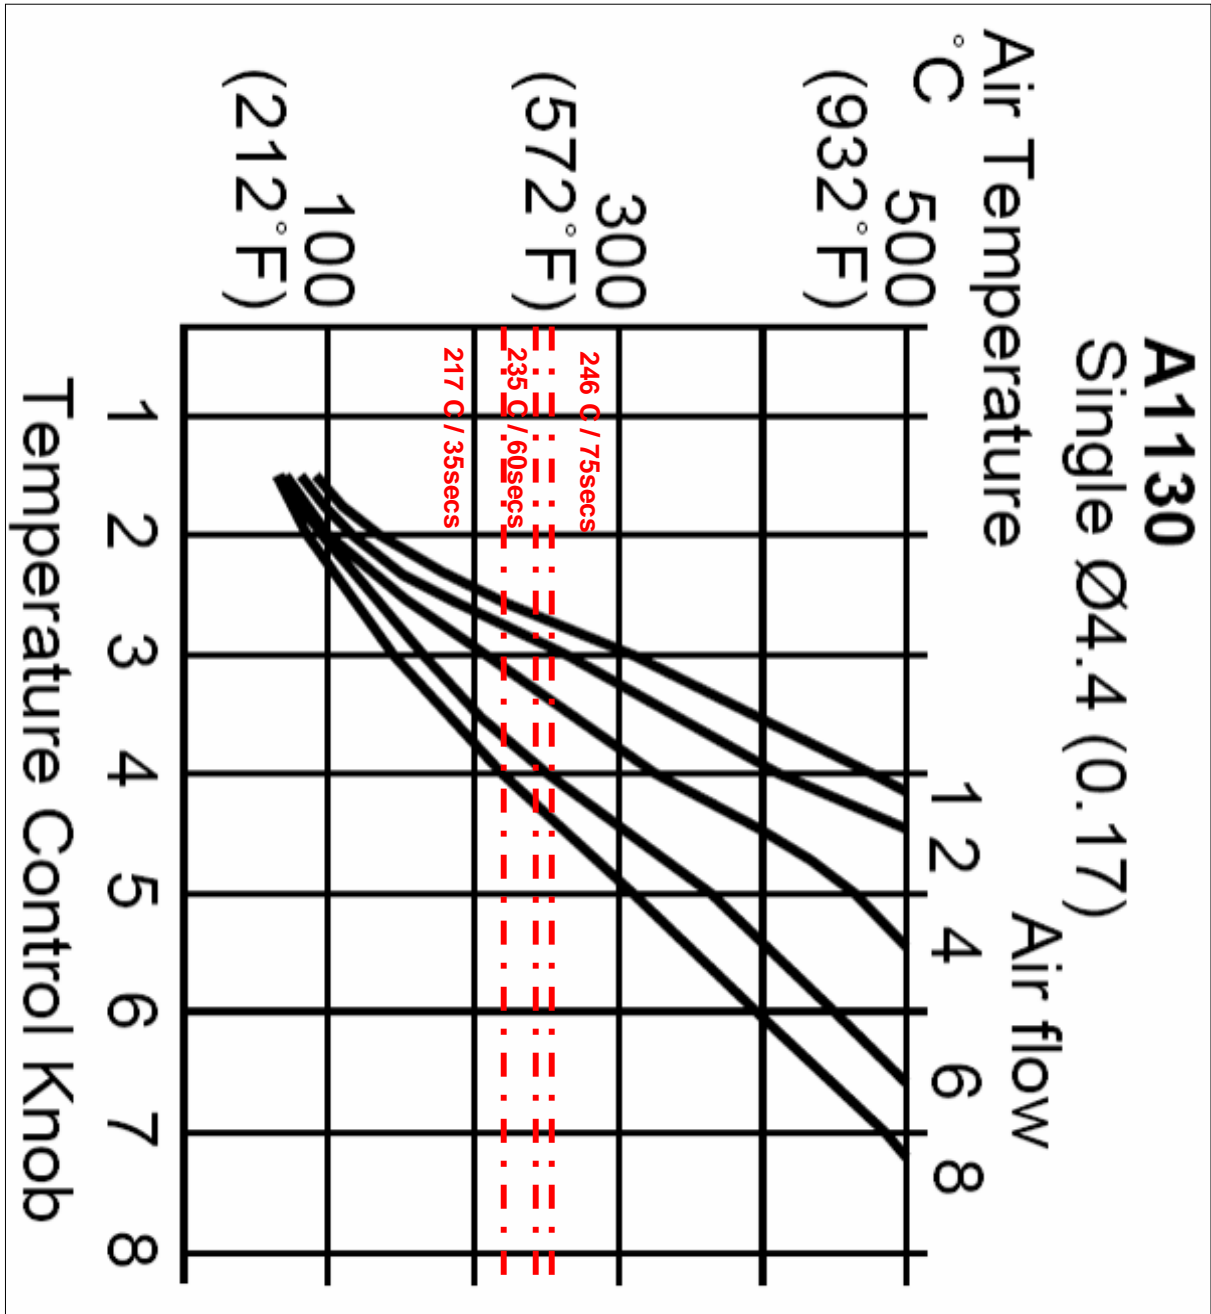
● Temperature Profile for Hakko-850D

- Condition: Measure at a point **2cm** from the nozzle (Type: A1130) by recorder.
